PROJECT DESCRIPTION : KMR DEMOLITION B509 & B522 AND REMOVAL AND DISPOSAL

JOB NO. CA-202007

Hazardous Materials Survey Project Number: 1207-00351-HAZ KMR Buildings 509, 552, 624, and 622D 522 Hilo, Hawaii

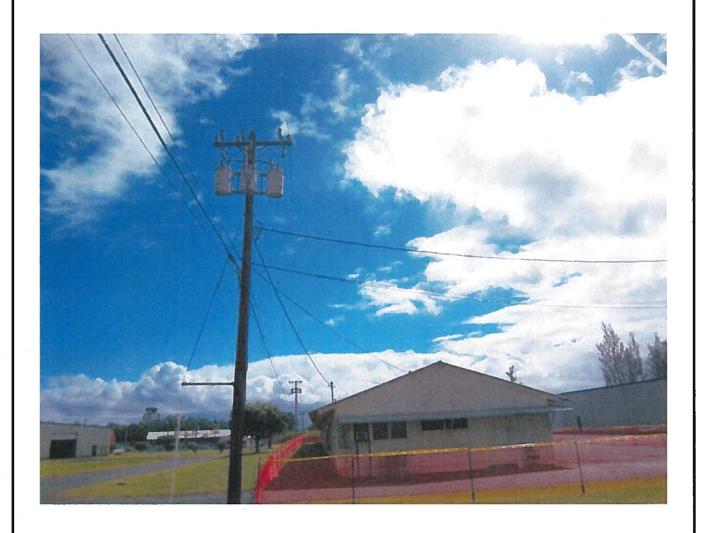
Pole-mounted electrical transformers were observed near the north and the west corners of Building 509. The transformers near the west corner of the building were identified with the following numbers: 32602, 32603, and 32575. The pole-mounted transformers near the north corner of the building were not clearly labeled.

The electrical transformers were not within the project site, however, if the transformers are to be disturbed, or should the transformers be observed to leak, they may contaminate the project site. No evidence of corrosion or leakage was observed at the time of the site visit. In the event that the pole-mounted transformers will be disturbed during demolition, the Hawaiian Electric Light Company (HELCO), or the owner of any privately-owned transformers should be contacted to confirm that the transformers are PCB-Free.

Photo 15Pole Mounted Transformers West of Building 509

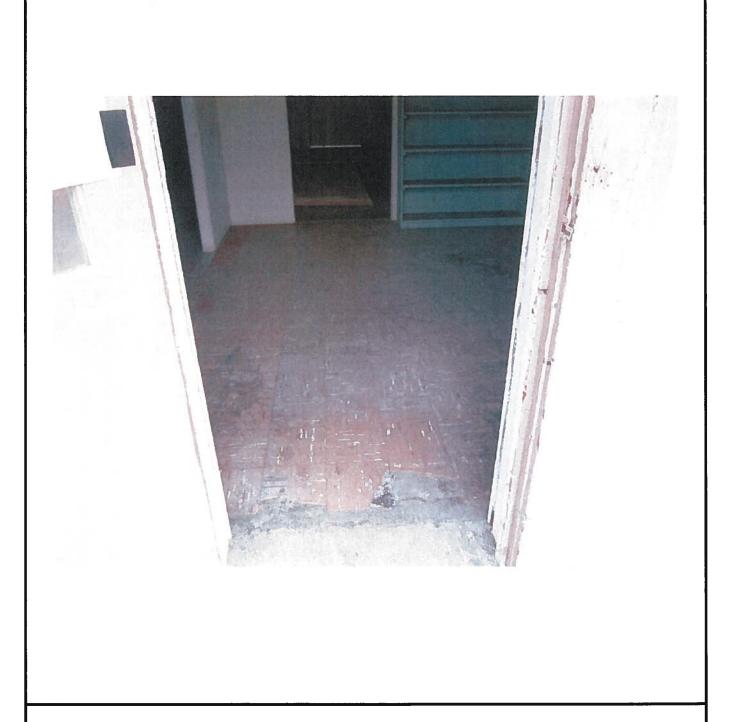
Photo 16Asbestos-Containing Vinyl Floor Tiles in Building 509

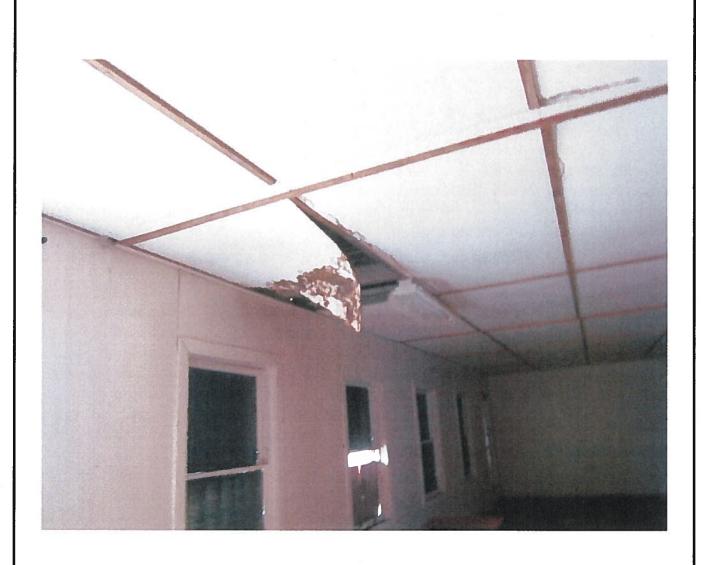
Photo 17Arsenic-Containing Canec Ceiling Material in Building 509

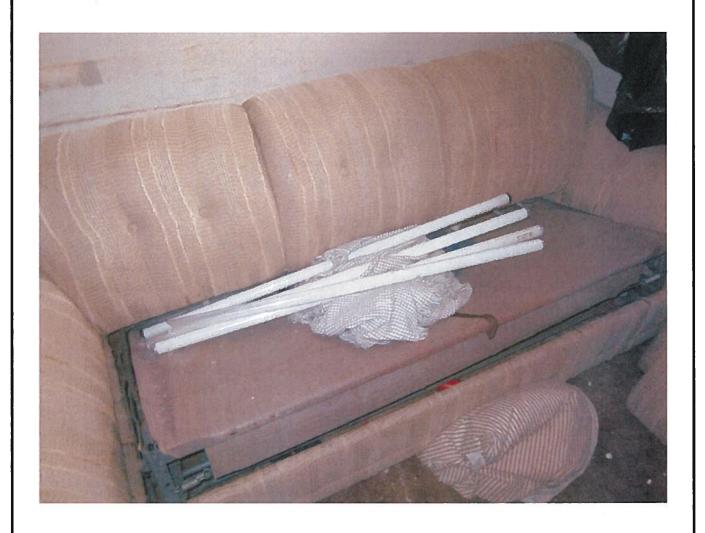
A total of fifty-seven fluorescent light fixtures and approximately twenty spare fluorescent tubes were observed on the project site. All fluorescent light tubes associated with these fixtures are considered to be mercury-containing.

Photo 20Mercury Containing Light Tubes Stored in Building 509

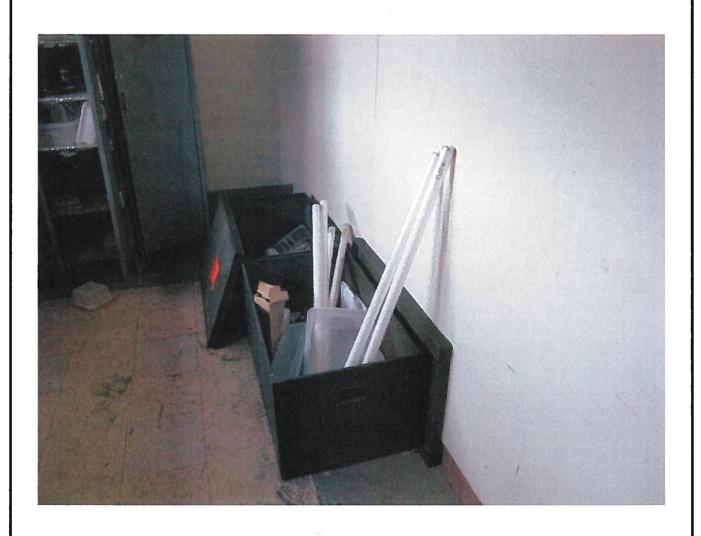
Photo 21Mercury Containing Light Tubes Stored in Building 509

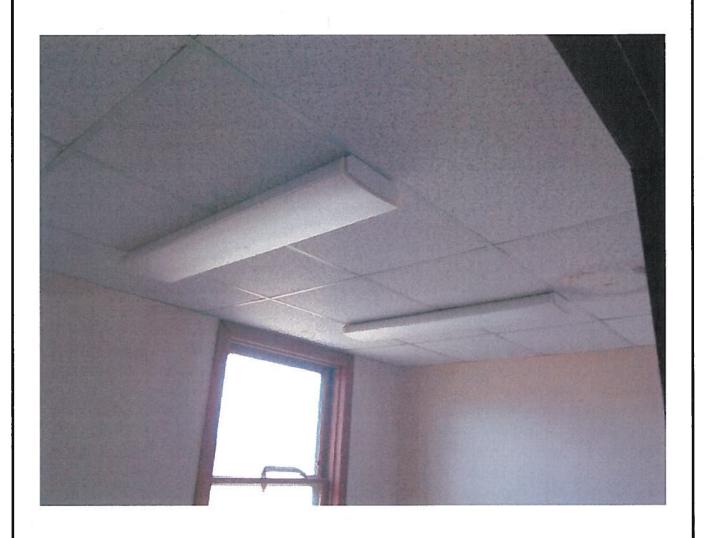
Photo 22

A total of fifty-seven fluorescent light fixtures were observed on the project site. All ballasts associated with the fifty-seven light fixtures are assumed to contain PCBs.

Possible PCB Containing Light Ballasts and Mercury Containing Light Tubes in Building 509

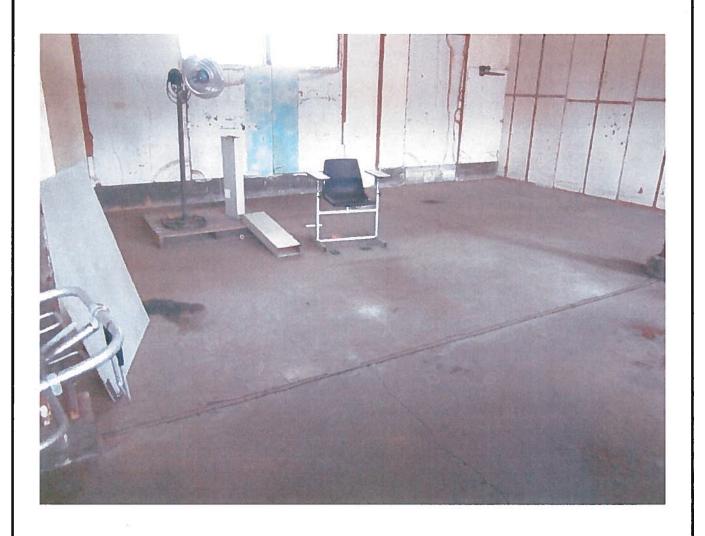
Photo 23Asbestos Containing Floor Tile in Building 509

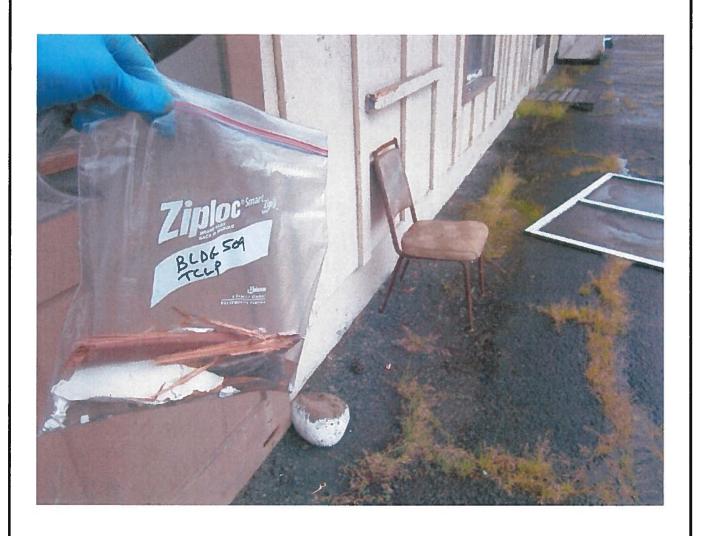
The building materials sampled from Building 509 are characteristic of hazardous waste based on their lead content. We recommend targeted sampling to reduce the amount of material requiring disposal as a hazardous waste.

Photo 25
TCLP Sample Collected from Building 509

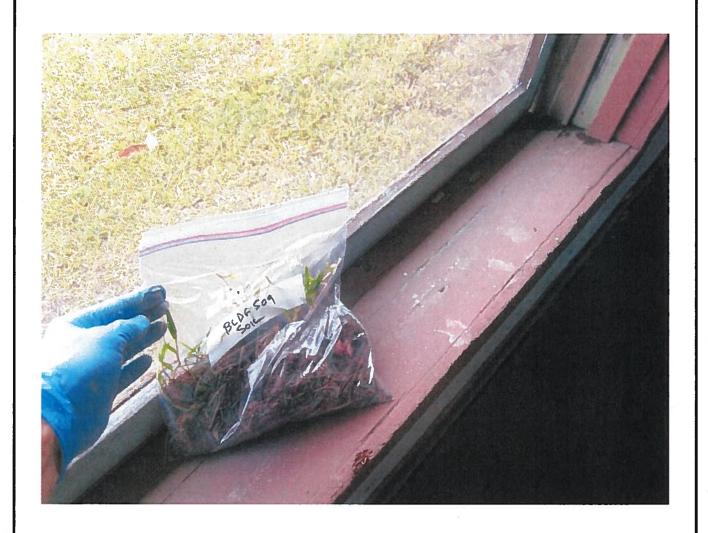
The Hazardous Materials Survey Report shows contamination of soil around each building's footprint. Contaminated soil around and underneath each building shall remain in place for encapsulation (remediation).

Photo 26
Composite Soil Sample Collected from Perimeter of Building 509

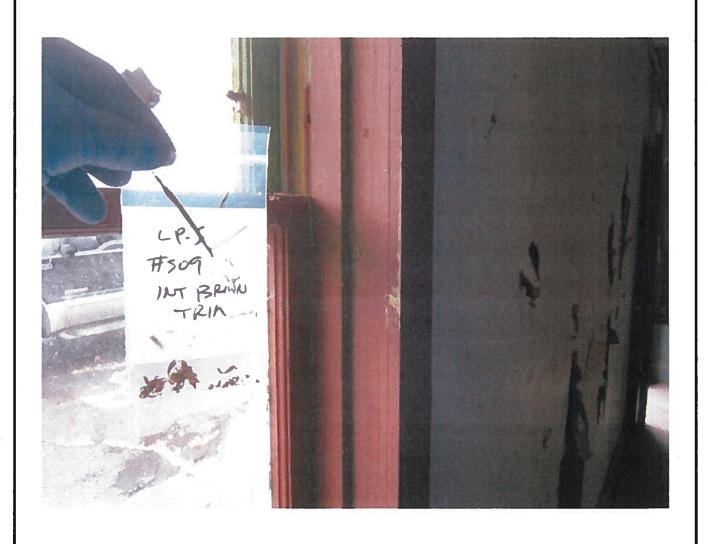
Photo 27Lead-Containing Interior Brown Trim Paint Sample LP-5

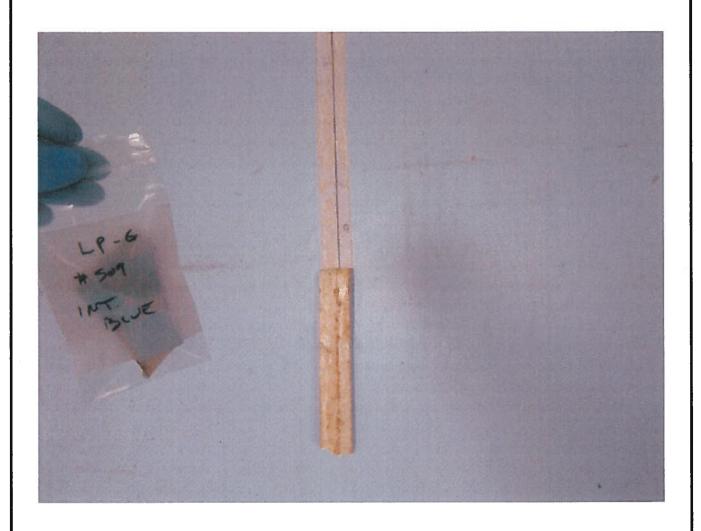
Photo 28
Lead-Containing Interior Blue Paint Sample LP-6

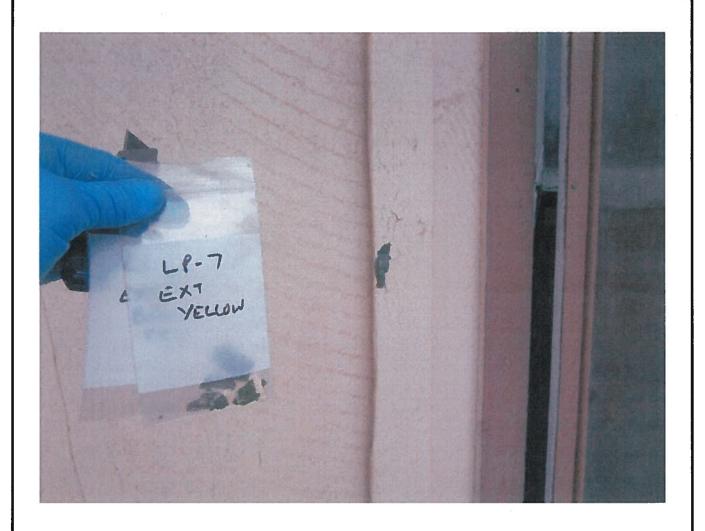
Photo 29

Building 509 Exterior Lead Based Paint (LBP) Sample LP-7 and LBP Brown Trim

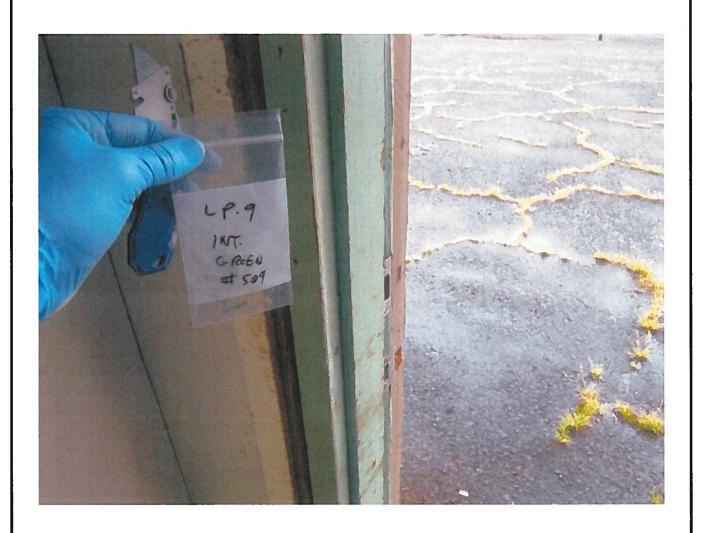
Photo 30Lead-Containing Interior Green Trim Paint Sample LP-9

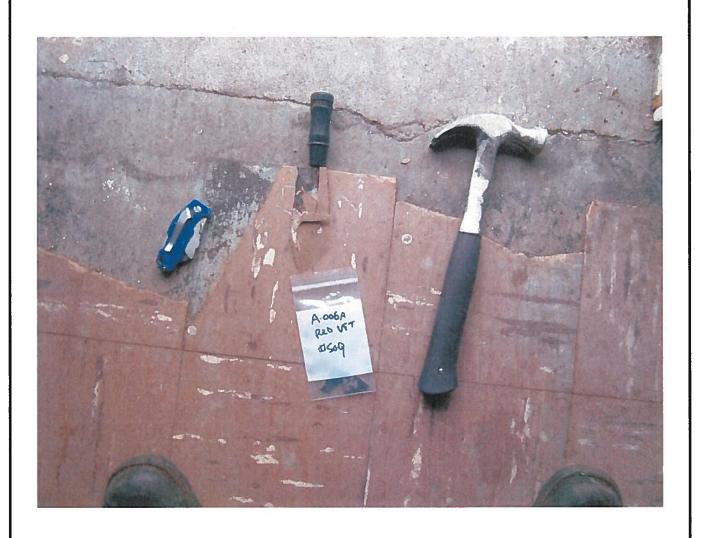
Photo 32

Asbsteos-Containing Vinyl Floor Tile and Mastic in Building 509 Sample A-006A

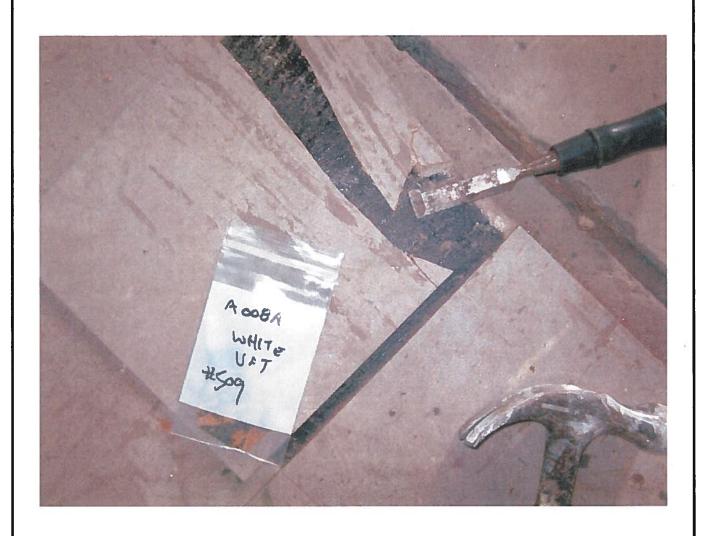
Photo 34Asbestos-Containing Vinyl Floor Tile and Mastic Sample A-008A

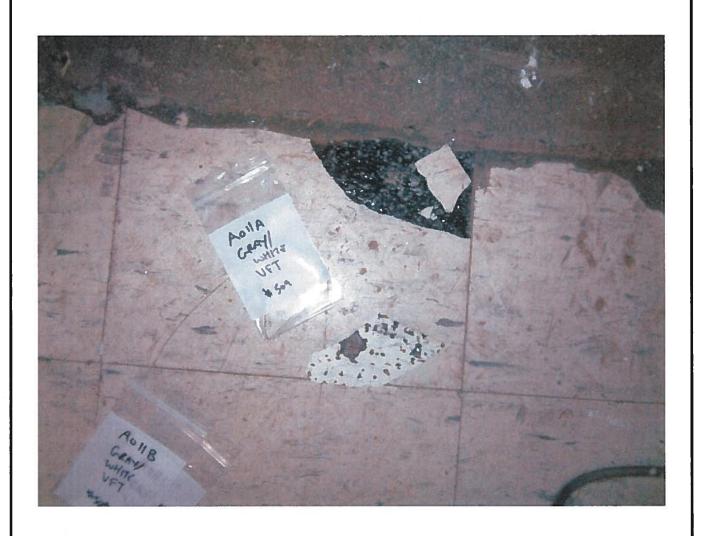
Photo 36Asbestos-Containing Vinyl Floor Tile and Mastic Sample A-011A

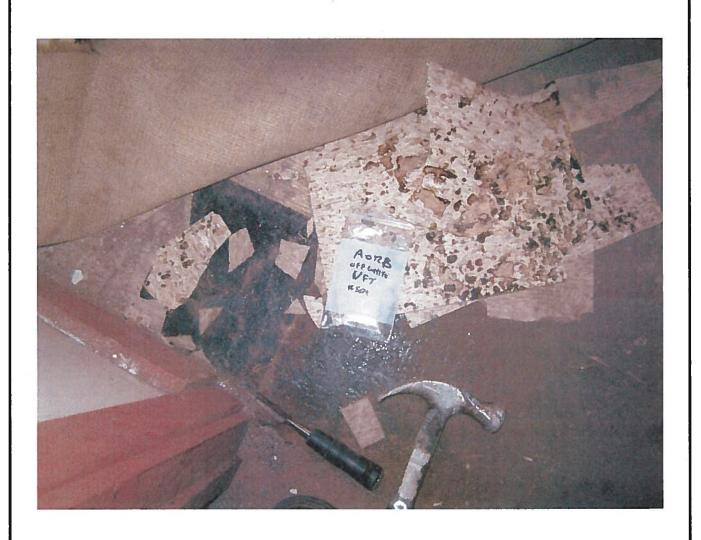
Photo 37
Asbestos-Containing Vinyl Floor Tile and Mastic Sample A-012B

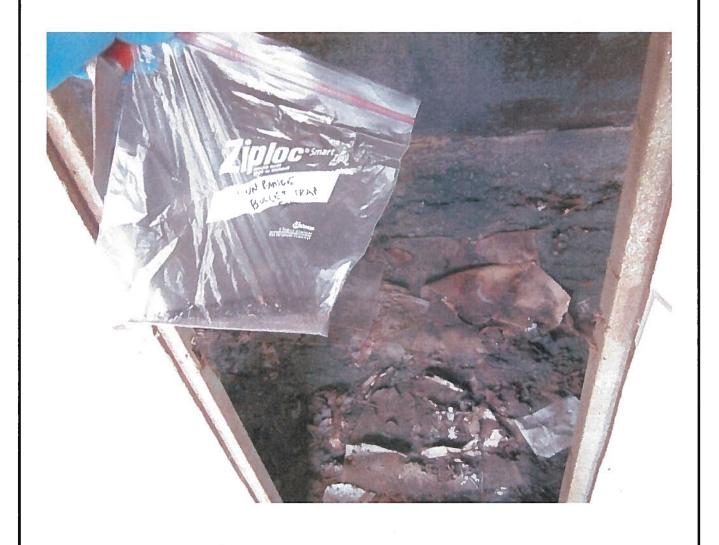
Photo 48

The Hazardous Materials Survey Report shows the leachable lead detected from the bullet trap of Bldg. 522 (Firing Range) was at <5 mg/L as determined by TCLP analysis. Hawaii landfill acceptance criteria is at <5 mg/L. The interested Bidder must include in their bid estimate the cost of removal and disposal of the bullet trap soil. It shall be the Bidder's responsibility to take site data (measurements of the bullet trap) to be used as basis of their quantity and cost estimates.

Lead Contaminated Soil Sample From Beneath Bullet Trap

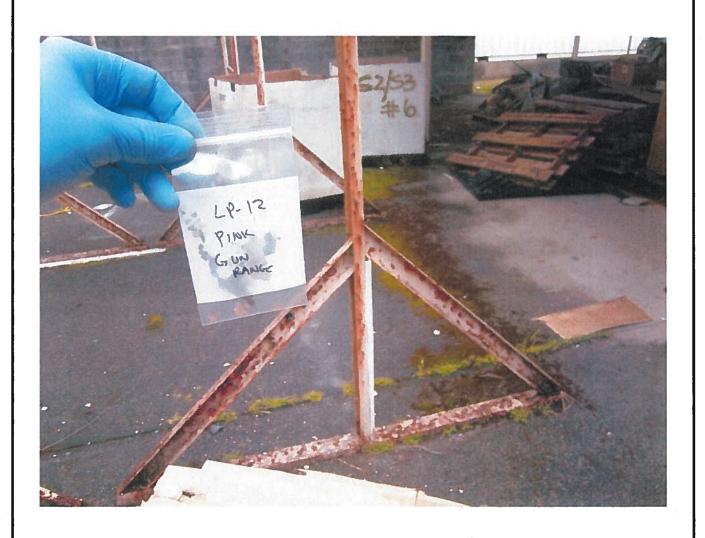
Photo 52
Lead-Containing Pink Paint Sample LP-12
