Limited Asbestos and Lead Paint Survey Report

**Roofs of Buildings 46, 1784, 1785 and 1788
Hawaii Air National Guard
91 Enterprise Street
Kapolei, Hawaii 96707**

**State of Hawaii - Department of Defense - Roof Repair/Replacement
Client Job No. CA-1419-D**

Date of Report: February 17, 2015

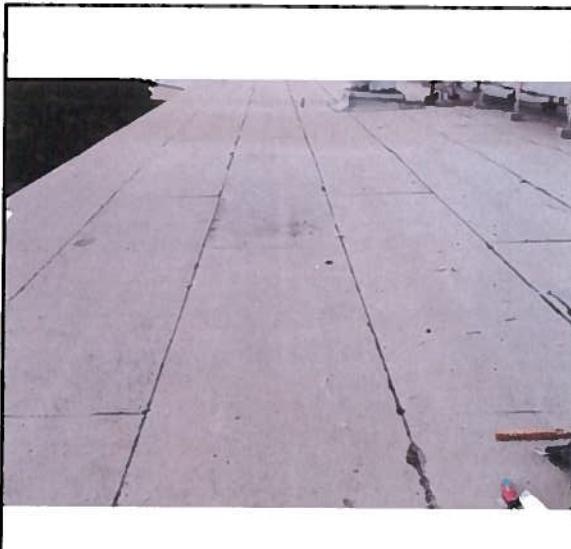
SAMPLE ANALYSIS SUMMARY SECTION			PHOTOGRAPH		
Total Number of Samples Collected	<input type="text"/> 3

Total Number of Samples Analyzed	<input type="text"/> 3				
ASBESTOS-CONTAINING MATERIAL ?	<input type="text"/> NO				
Samples Collected by	<input type="text"/> EMET				
Sample Numbers	<input type="text"/> 311-46-RA(L1)1, 311-46-RA(L1)2, 311-46-RA(L1)3				
Samples Analyzed by	<input type="text"/> EMET				
Number of Salient Designations	<input type="text"/>

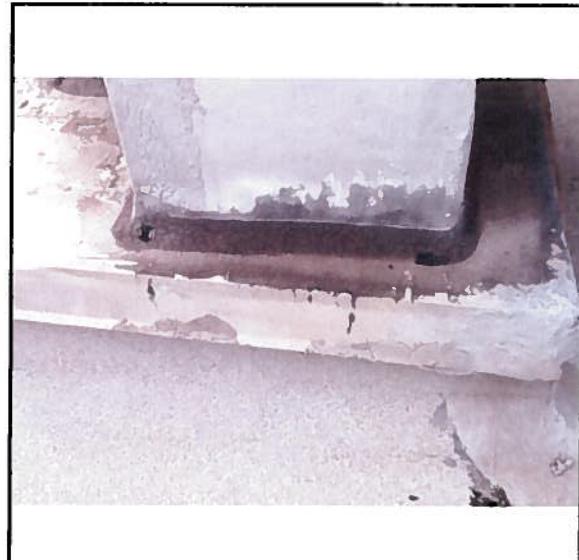
Physical Condition	Potential Damage	Water Damage
None	Moderate	None
Visible	Reachable	Texture
More than 10%	Not reachable	
Barriers	Ventilation	If Yes
Enclosed	No	Friable Surface
Air Movement	Proximity to Repair Items	Activity
High	Less than 1 ft.	Low

Total Number of Samples Collected	3
Total Number of Samples Analyzed	3
ASBESTOS-CONTAINING MATERIAL ?	YES
Samples Collected by	EMET
Sample Numbers	311-46-RE1, 311-46-RE2, 311-46-RE3
Samples Analyzed by	EMET
Number of Salient Designations

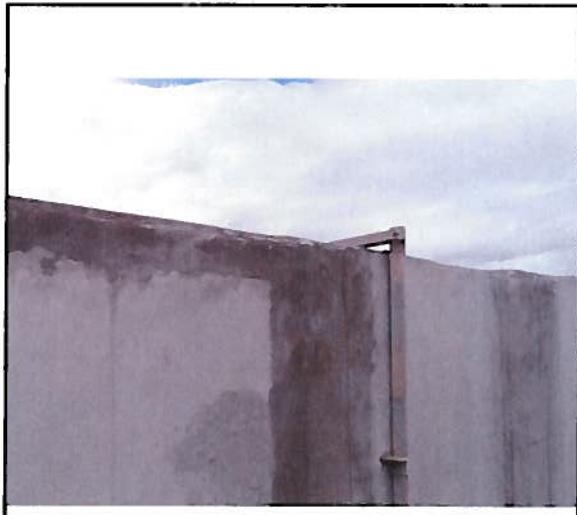
Physical Condition	Potential Damage	Water Damage
None	Moderate	None
Visible	Reachable	Texture
More than 10%	Within reach	
Barriers	Ventilation	If Yes
Enclosed	No	No Category I
Air Movement	Proximity to Repair Items	Friable Surface
High	Less than 1 ft.	Activity
		Low

Total Number of Samples Collected	3
Total Number of Samples Analyzed	3
ASBESTOS-CONTAINING MATERIAL ?	YES
Samples Collected by	EMET
Sample Numbers	311-46-RF1, 311-46-RF2, 311-46-RF3
Samples Analyzed by	EMET
Number of Salient Designations

Building Number and Name		EMET ID
46	building 46	1408311
Sample Area/Lot Number and Name		
311-46-RF	gray/black patch/sealant

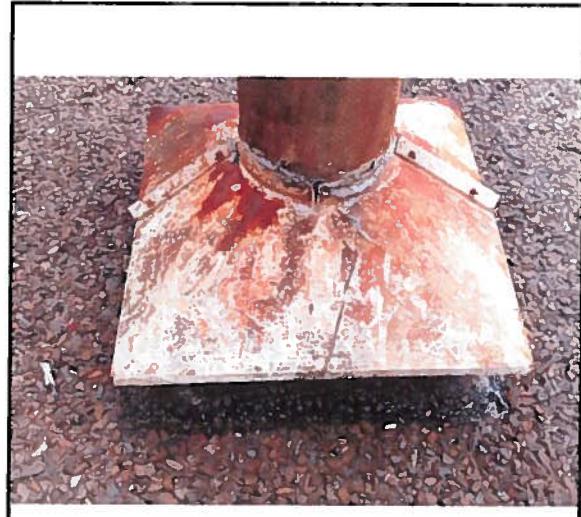
PHOTOGRAPH

Total Number of Samples Collected	3
Total Number of Samples Analyzed	3
ASBESTOS-CONTAINING MATERIAL ?	YES
Samples Collected by	EMET
Sample Numbers	311-46-LRB1, 311-46-LRB2, 311-46-LRB3
Samples Analyzed by	EMET
Number of Salient Designations

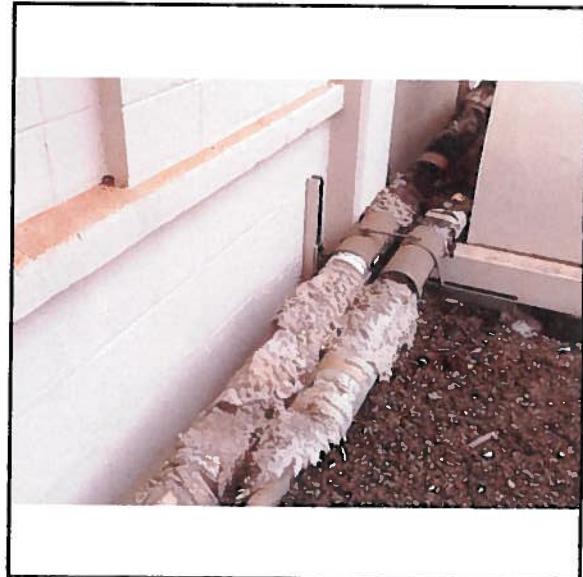
PHOTOGRAPH

Total Number of Samples Collected	3
Total Number of Samples Analyzed	3
ASBESTOS-CONTAINING MATERIAL ?	NO
Samples Collected by	EMET
Sample Numbers	311-46-LRD(L1)1, 311-46-LRD(L1)2, 311-46-LRD(L1)3
Samples Analyzed by	EMET
Number of Salient Designations

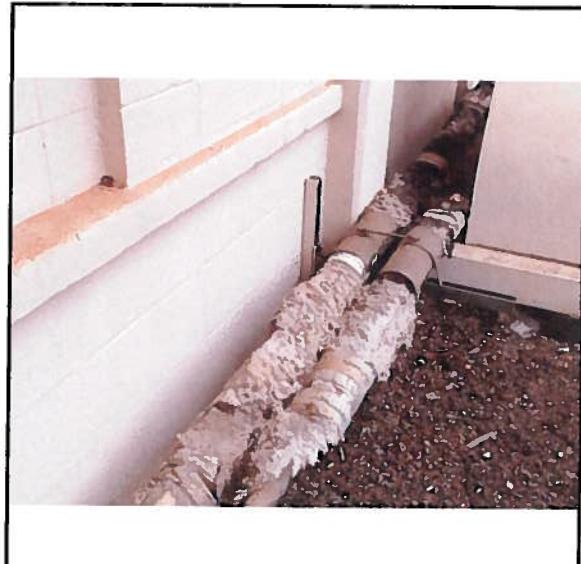
PHOTOGRAPH

Total Number of Samples Collected	3
Total Number of Samples Analyzed	3
ASBESTOS-CONTAINING MATERIAL ?	
Samples Collected by	EMET
Sample Numbers	311-46-LRD(L2)1, 311-46-LRD(L2)2, 311-46-LRD(L2)3
Samples Analyzed by	EMET
Number of Salient Designations

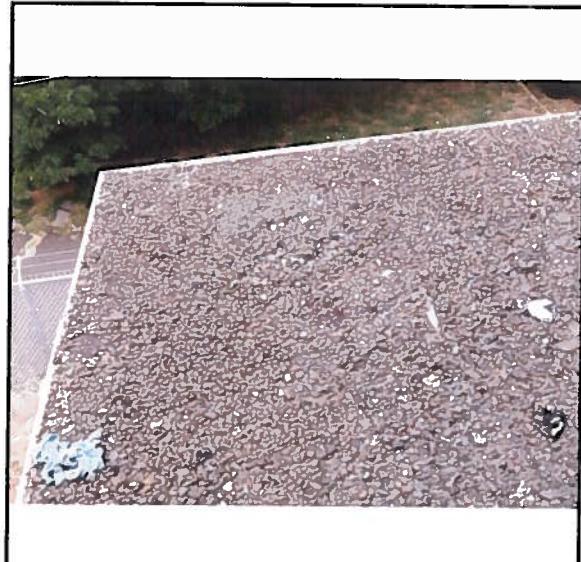
Building Number and Name		EMET ID
46	building 46	1408311
Sample Area/Lot Number and Name		
311-46-MRA(L2)	pitch & gravel built-up roof system

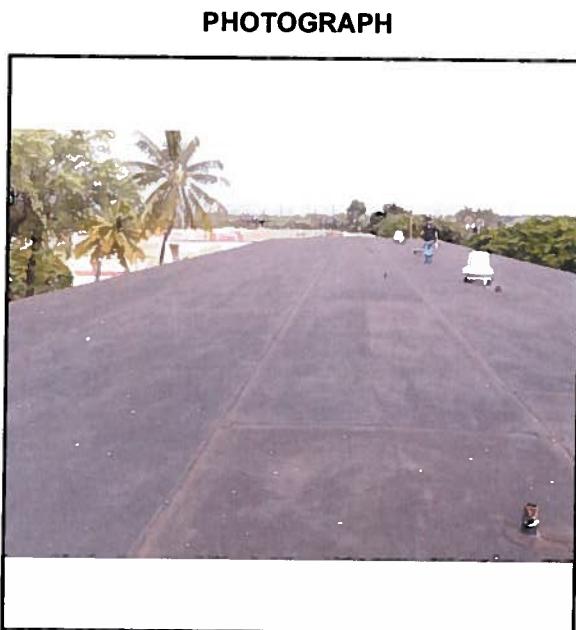
Building Number and Name		EMET ID
1784	building 1784	1408311
Sample Area/Lot Number and Name		
311-1784-RA(L2)	black weather membrane built up roof system

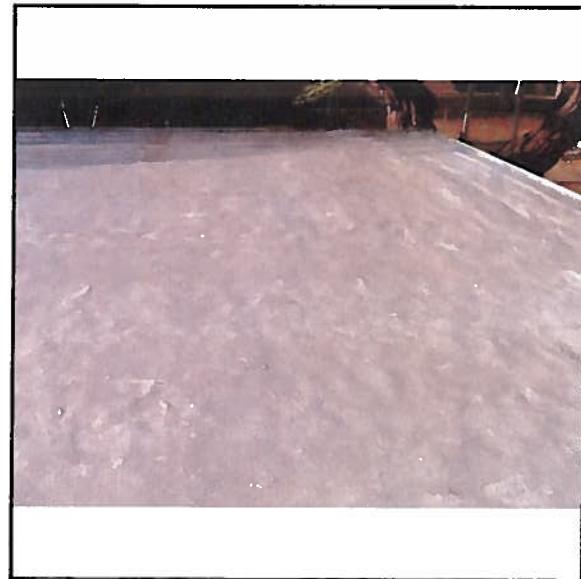
PHOTOGRAPH

Building Number and Name		EMET ID
1785	building 1785	1408311
Sample Area/Lot Number and Name		
311-1785-RA(L1)	white weather membrane built up roof system

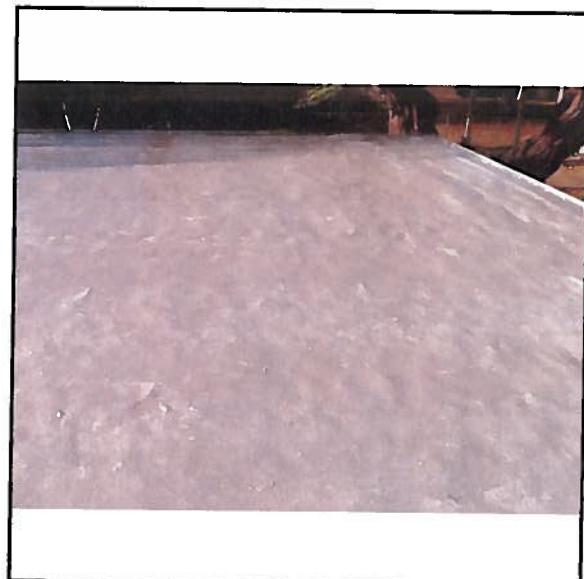
PHOTOGRAPH

Building Number and Name		EMET ID
1785	building 1785	1408311
Sample Area/Lot Number and Name		
311-1785-RA(L4)	white weather membrane built up roof system

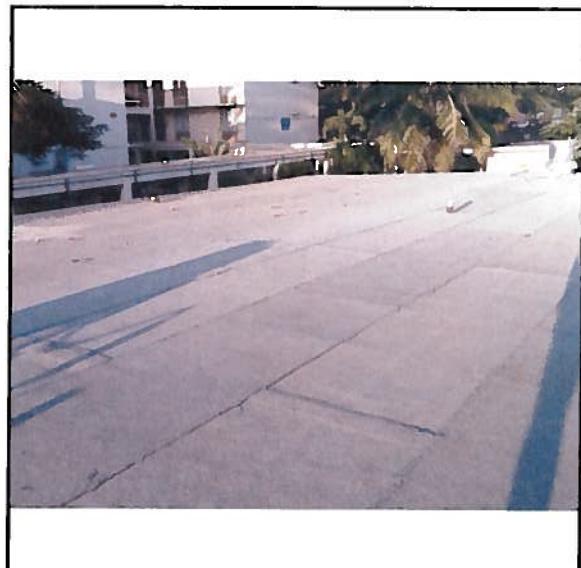
Building Number and Name		EMET ID
1785	building 1785	1408311
Sample Area/Lot Number and Name		
311-1785-RB	gray caulking

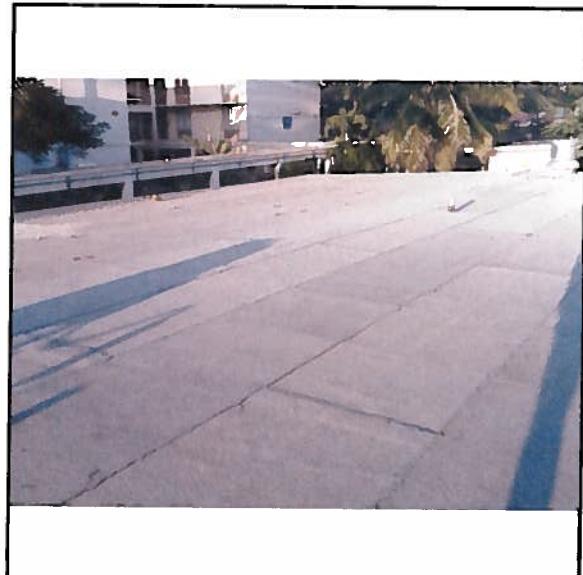
Building Number and Name		EMET ID
1788	building 1788	1408311
Sample Area/Lot Number and Name		
311-1788-RA(L1)	gray mineral capsheet built-up roof system

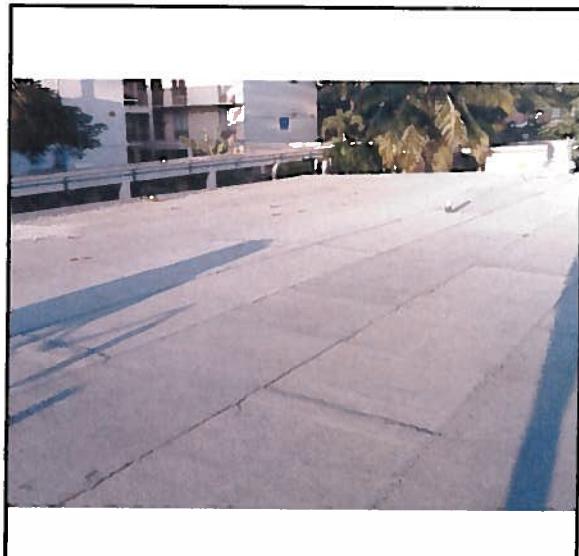
Building Number and Name		EMET ID
1788	building 1788	1408311
Sample Area/Lot Number and Name		
311-1788-RA(L2)	gray mineral capsheet built-up roof system

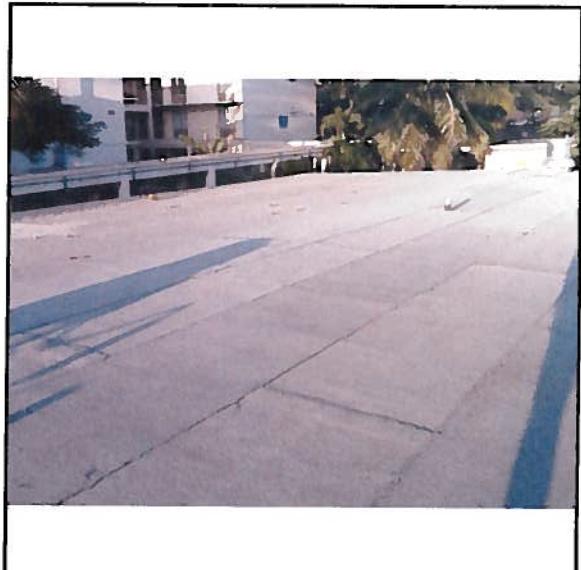
PHOTOGRAPH

Total Number of Samples Collected	3
Total Number of Samples Analyzed	3
ASBESTOS-CONTAINING MATERIAL ?	NO
Samples Collected by	EMET
Sample Numbers	311-1788-RA(L4)1, 311-1788-RA(L4)2, 311-1788-RA(L4)3
Samples Analyzed by	EMET
Number of Salient Designations	[Redacted]

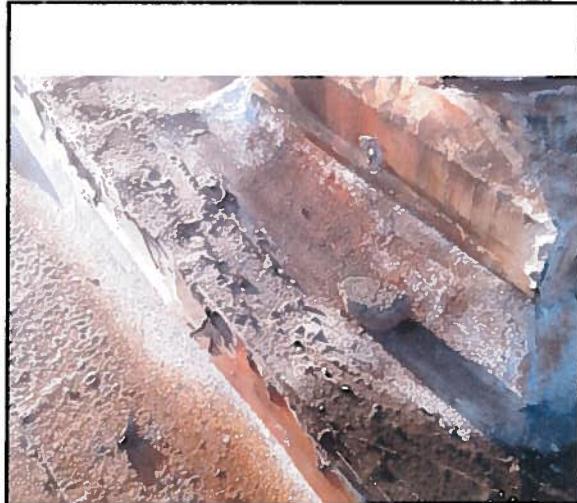
PHOTOGRAPH

Building Number and Name		EMET ID
1788	building 1788	1408311
Sample Area/Lot Number and Name		
311-1788-RC	gray patch/sealant

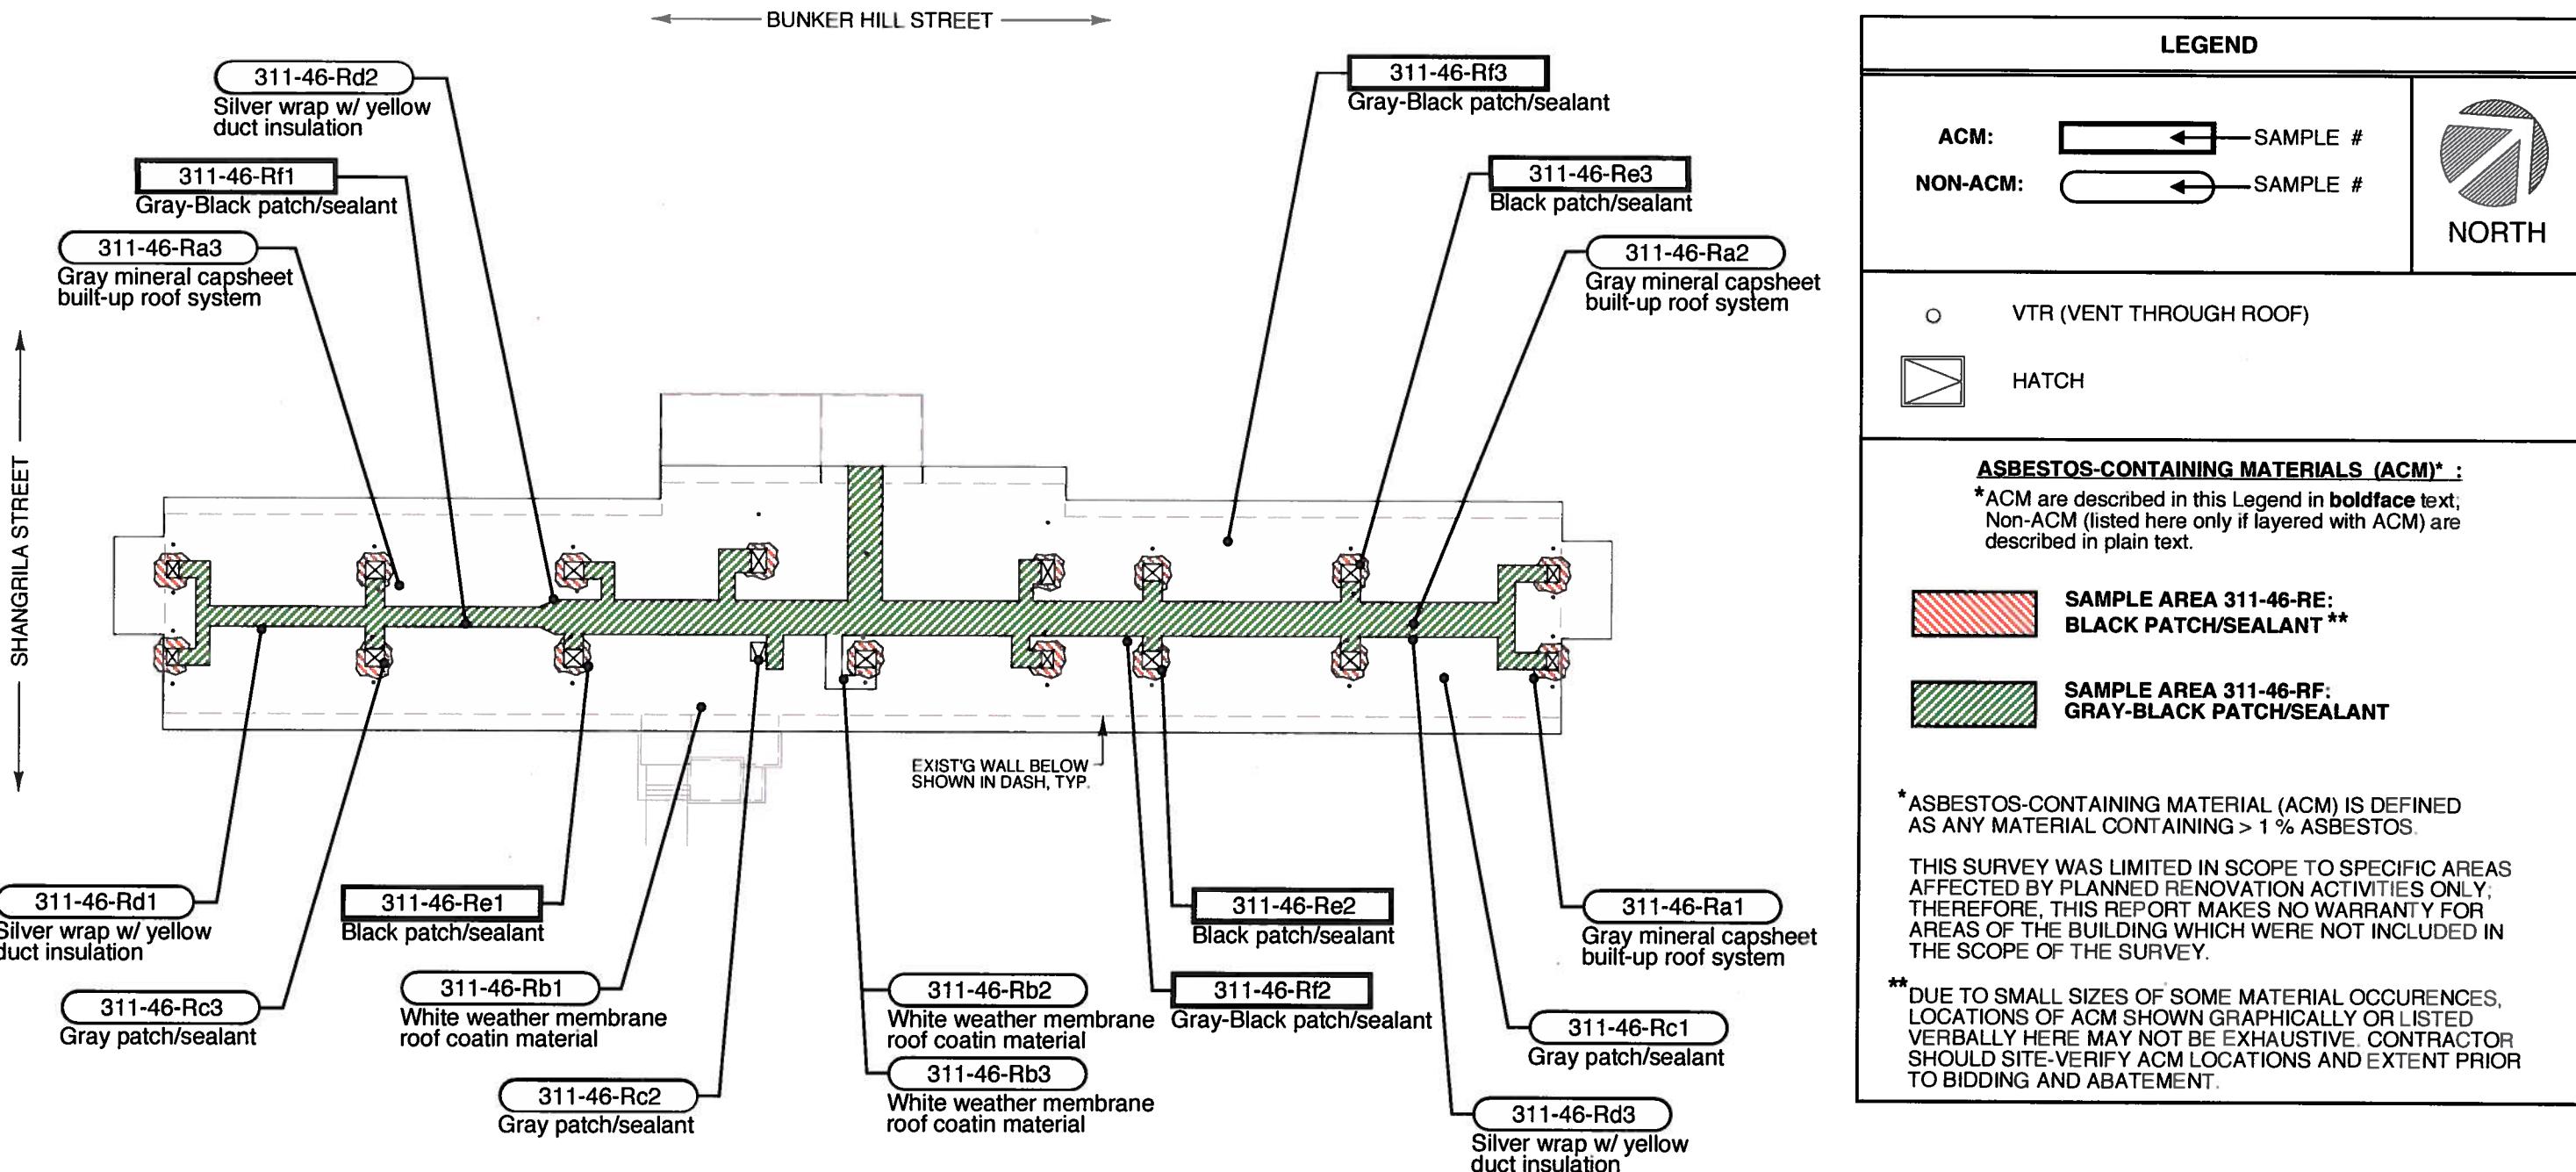
BLDG #	NAME OF BUILDING	ADDRESS	SKETCH #
46	BUILDING 46	91 ENTERPRISE STREET KAPOLEI, HI 96707	311-46-R 1 OF 1

**HAWAII AIR NATIONAL GUARD (DEPARTMENT OF DEFENSE)
BUILDING "46" - ROOF PLAN (MAIN/ HIGHER ROOF)**
NOT TO SCALE

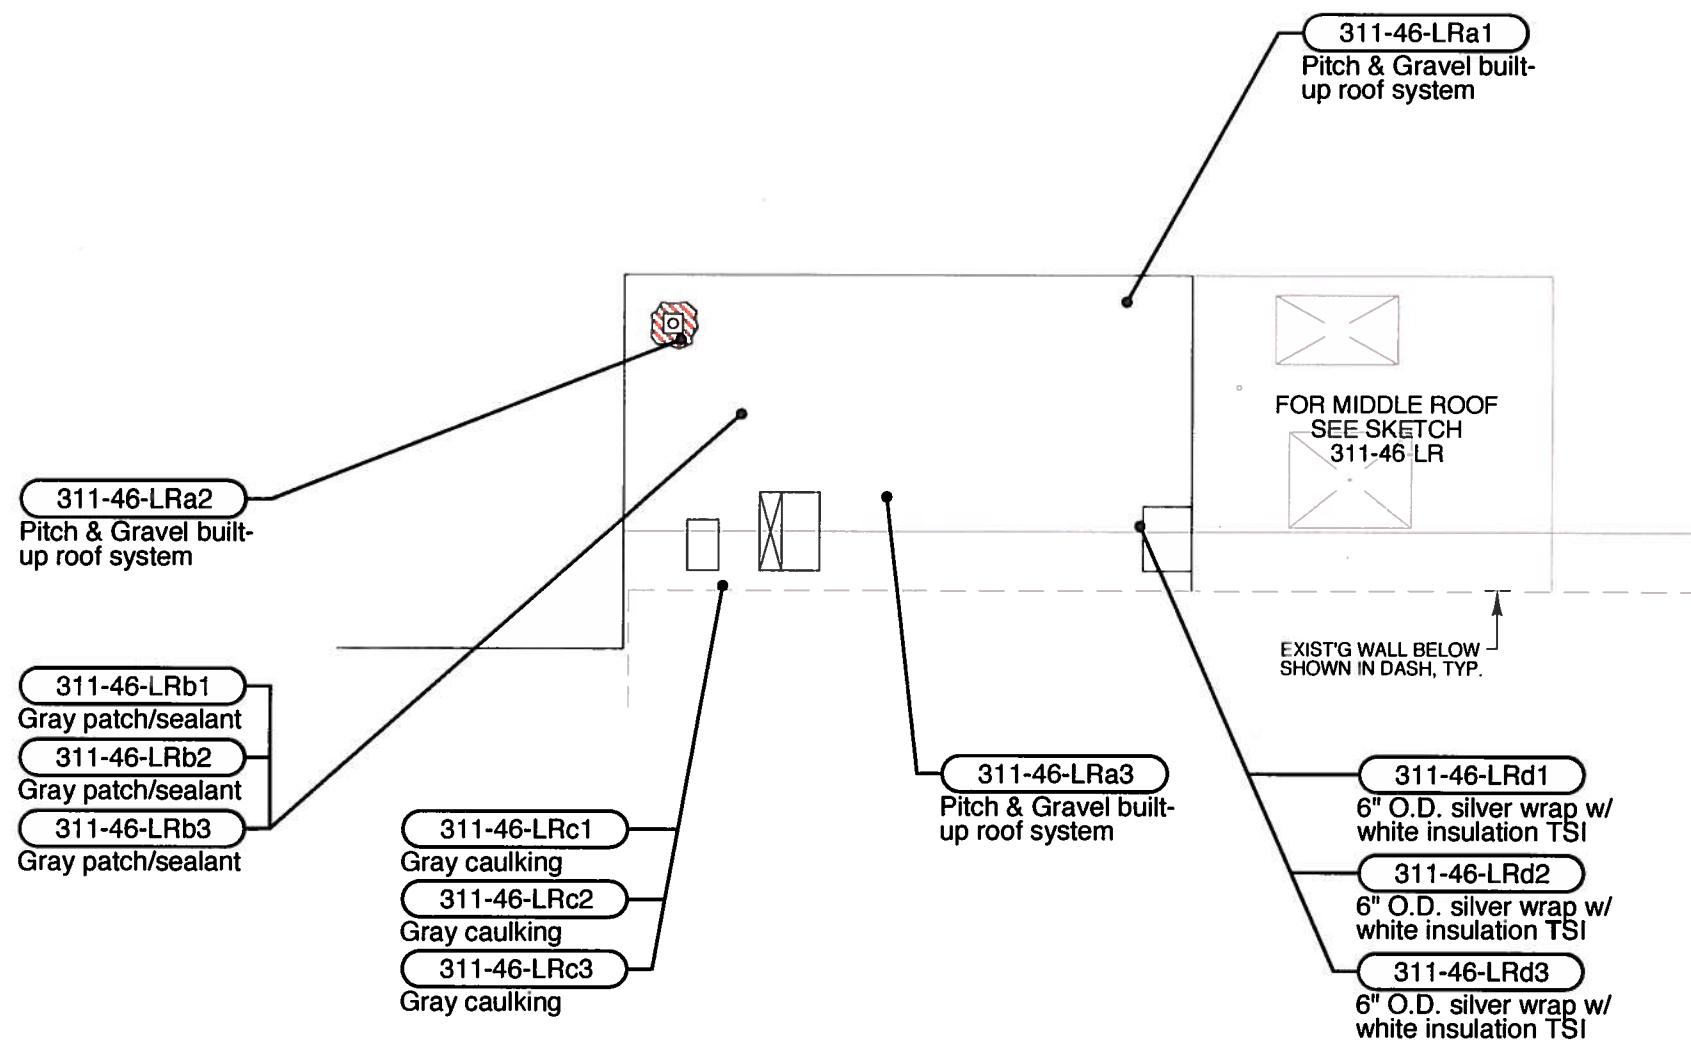
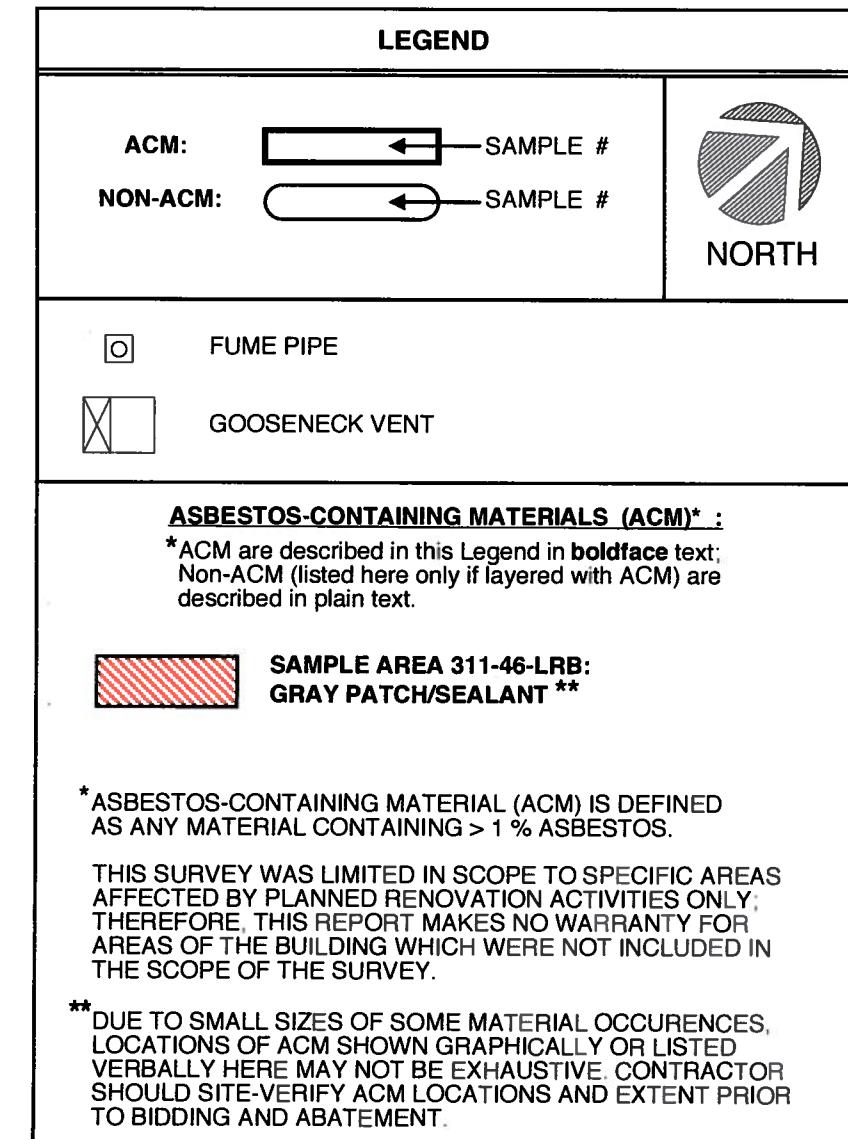
BLDG #	NAME OF BUILDING	ADDRESS	SKETCH #
46	BUILDING 46	91 ENTERPRISE STREET KAPOLEI, HI 96707	311-46-LR 1 OF 1

HAWAII AIR NATIONAL GUARD (DEPARTMENT OF DEFENSE)
BUILDING "46" - ROOF PLAN (LOWER ROOF)
NOT TO SCALE

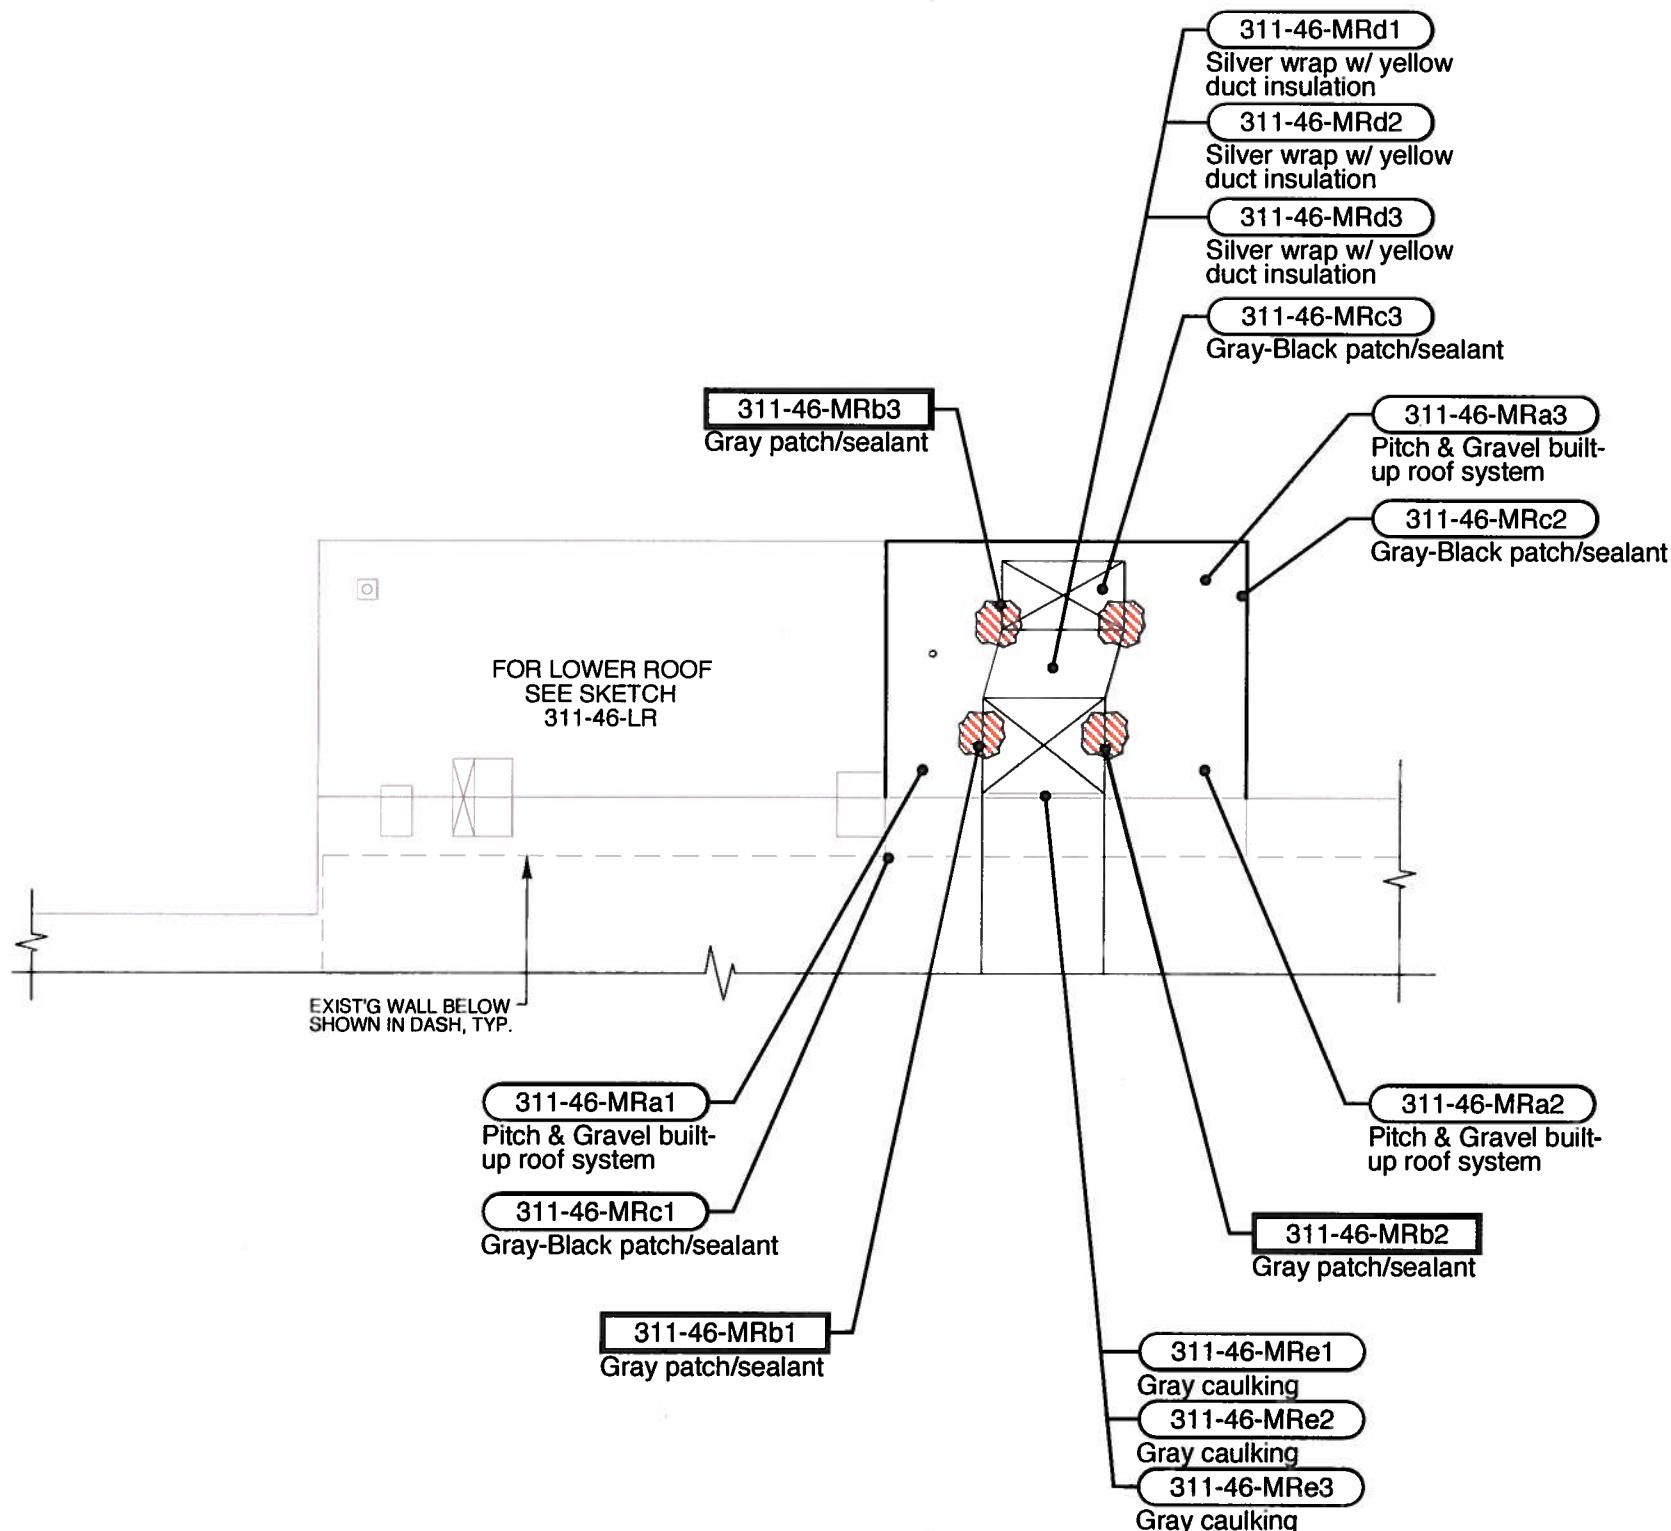
BLDG #	NAME OF BUILDING	ADDRESS	SKETCH #
46	BUILDING 46	91 ENTERPRISE STREET KAPOLEI, HI 96707	311-46-MR 1 OF 1

**HAWAII AIR NATIONAL GUARD (DEPARTMENT OF DEFENSE)
BUILDING "46" - ROOF PLAN (MIDDLE ROOF)**
NOT TO SCALE

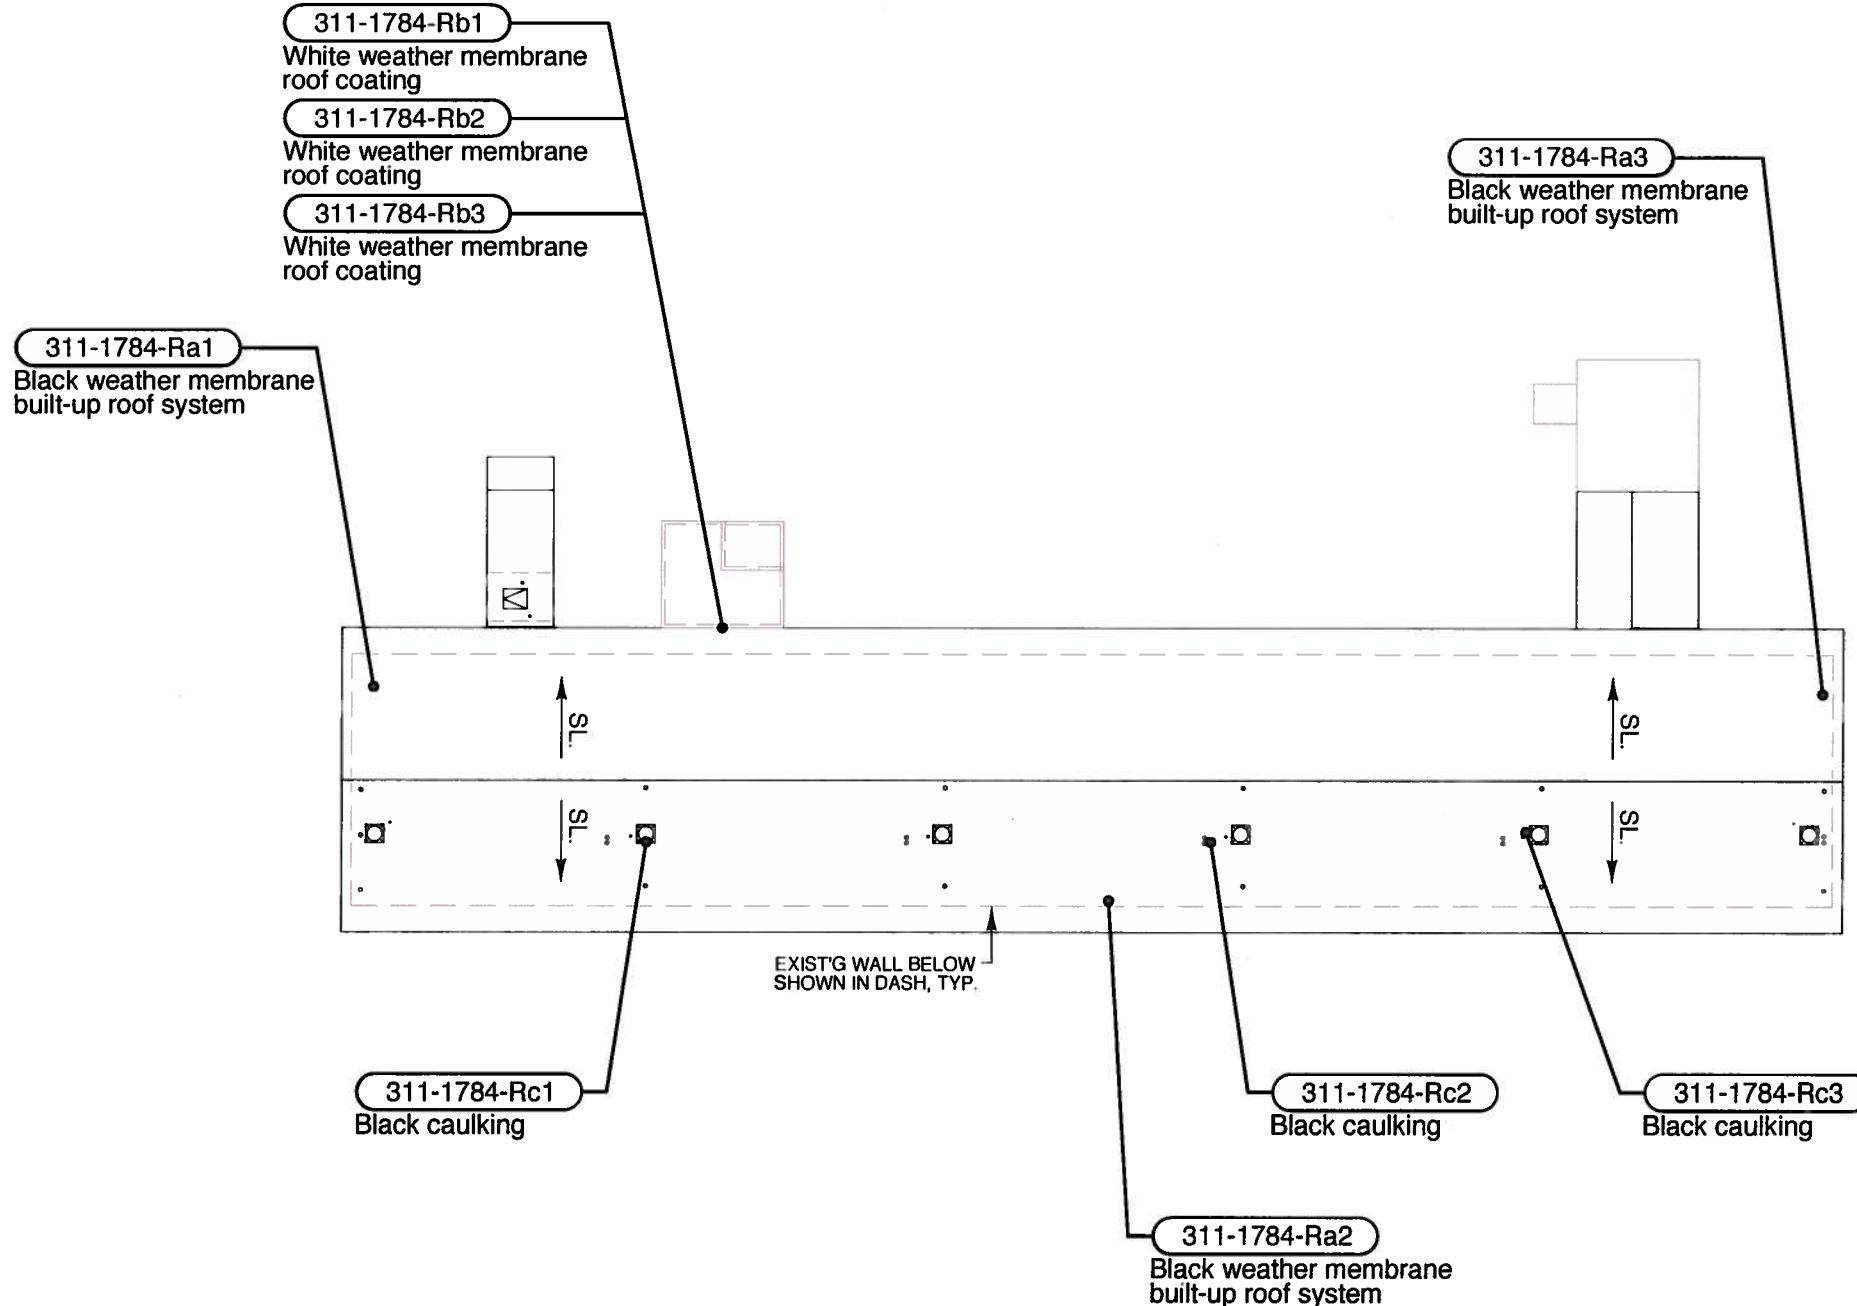
BLDG #	NAME OF BUILDING	ADDRESS	SKETCH #
1784	BUILDING 1784	91 ENTERPRISE STREET KAPOLEI, HI 96707	311-1784-R 1 OF 1

HAWAII AIR NATIONAL GUARD (DEPARTMENT OF DEFENSE)
BUILDING "1784" - ROOF PLAN
 NOT TO SCALE

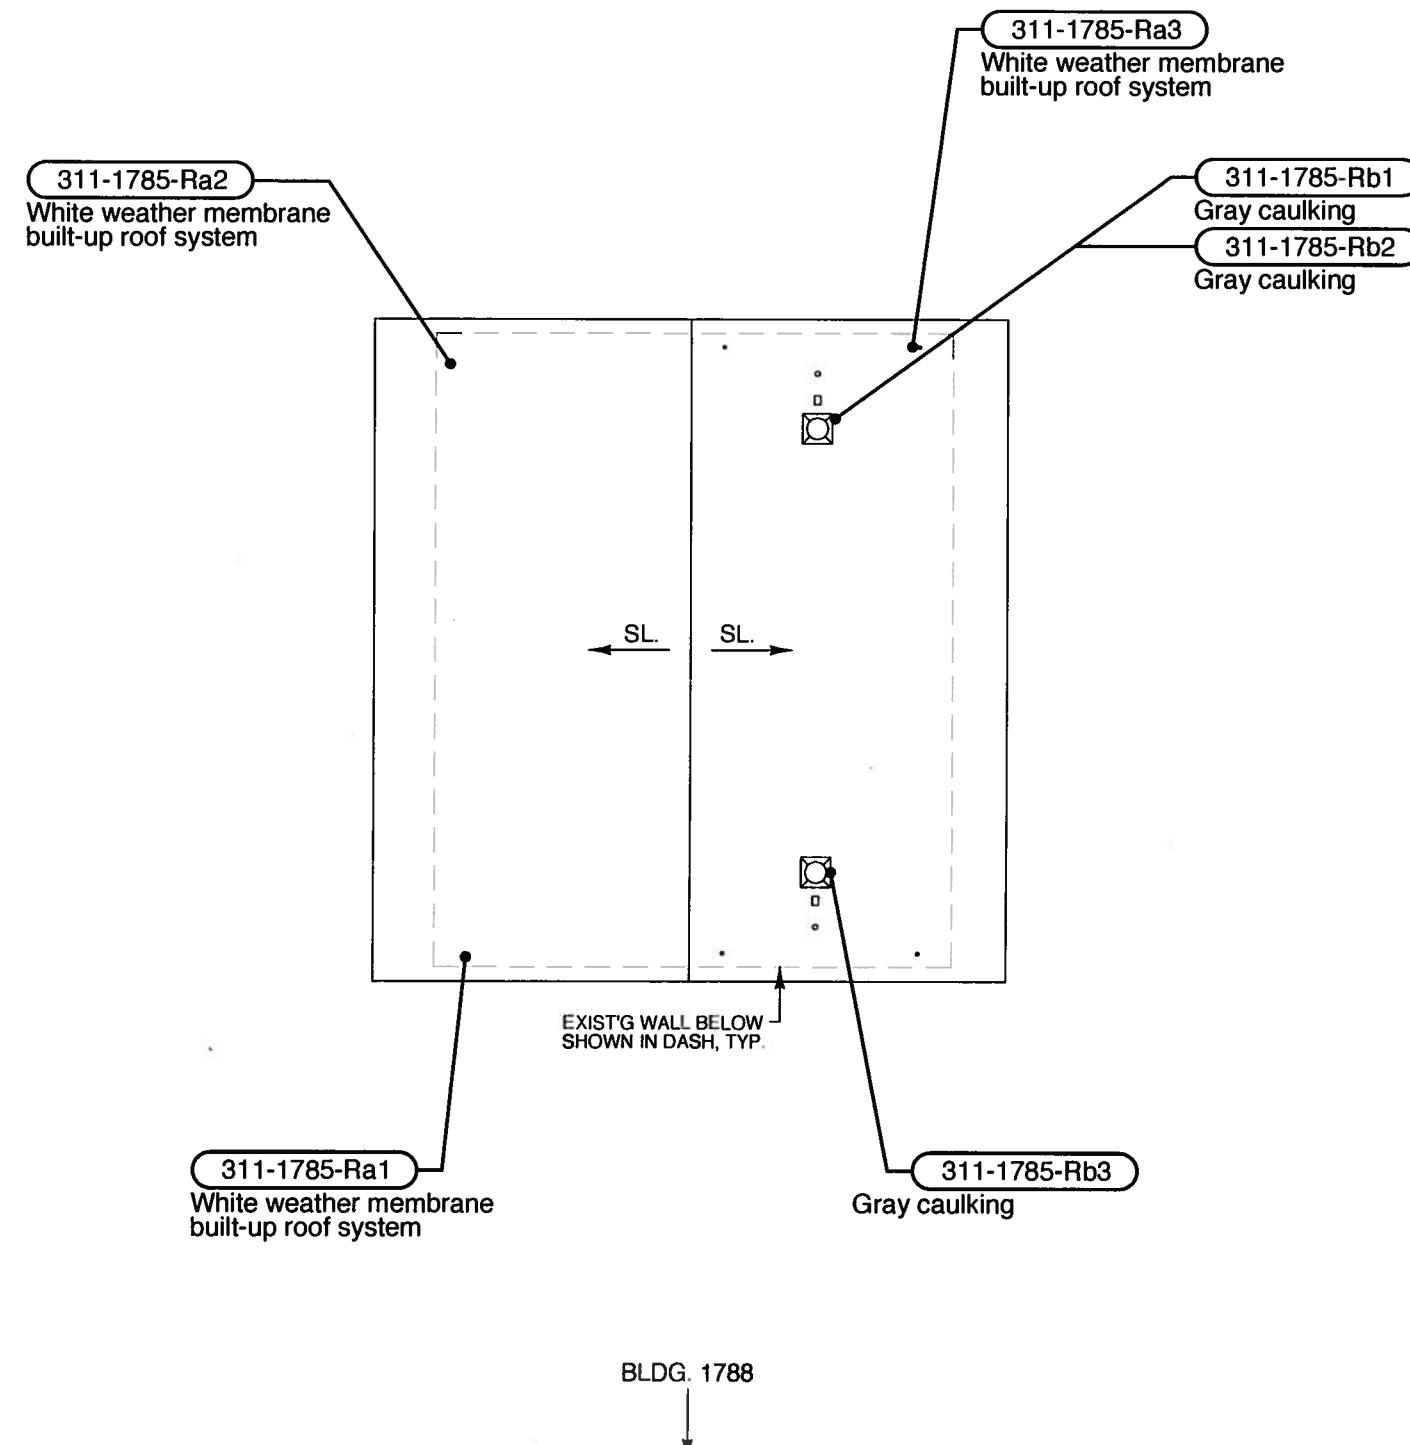
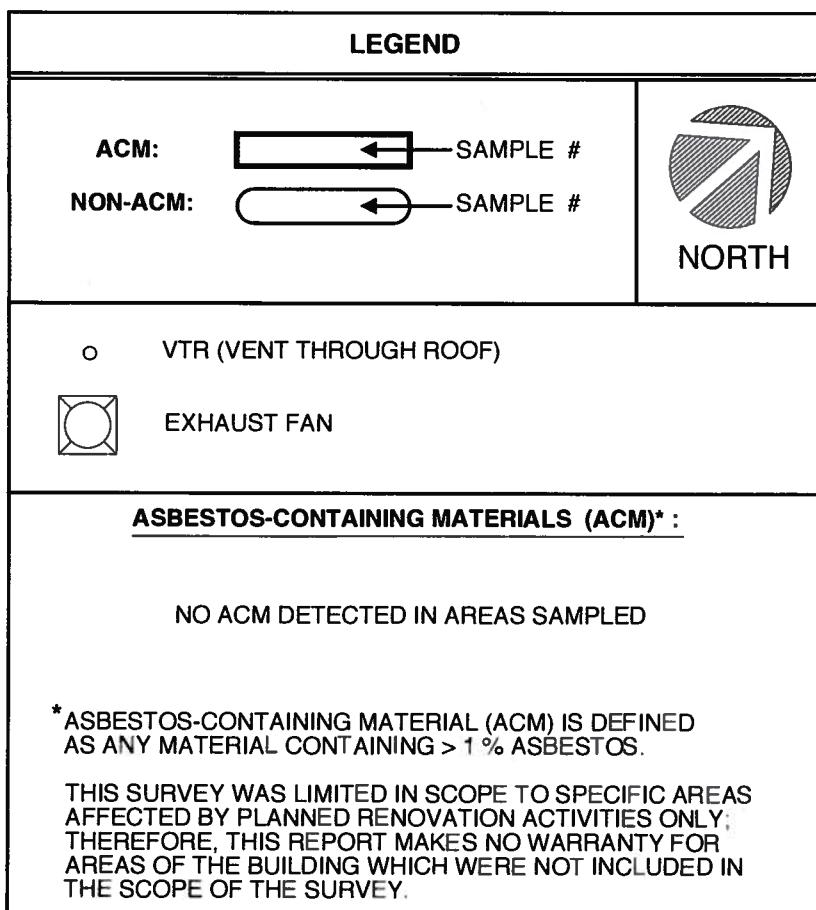
BLDG #	NAME OF BUILDING	ADDRESS	SKETCH #
1785	BUILDING 1785	91 ENTERPRISE STREET KAPOLEI, HI 96707	311-1785-R 1 OF 1

HAWAII AIR NATIONAL GUARD (DEPARTMENT OF DEFENSE)
BUILDING "1785" - ROOF PLAN
NOT TO SCALE

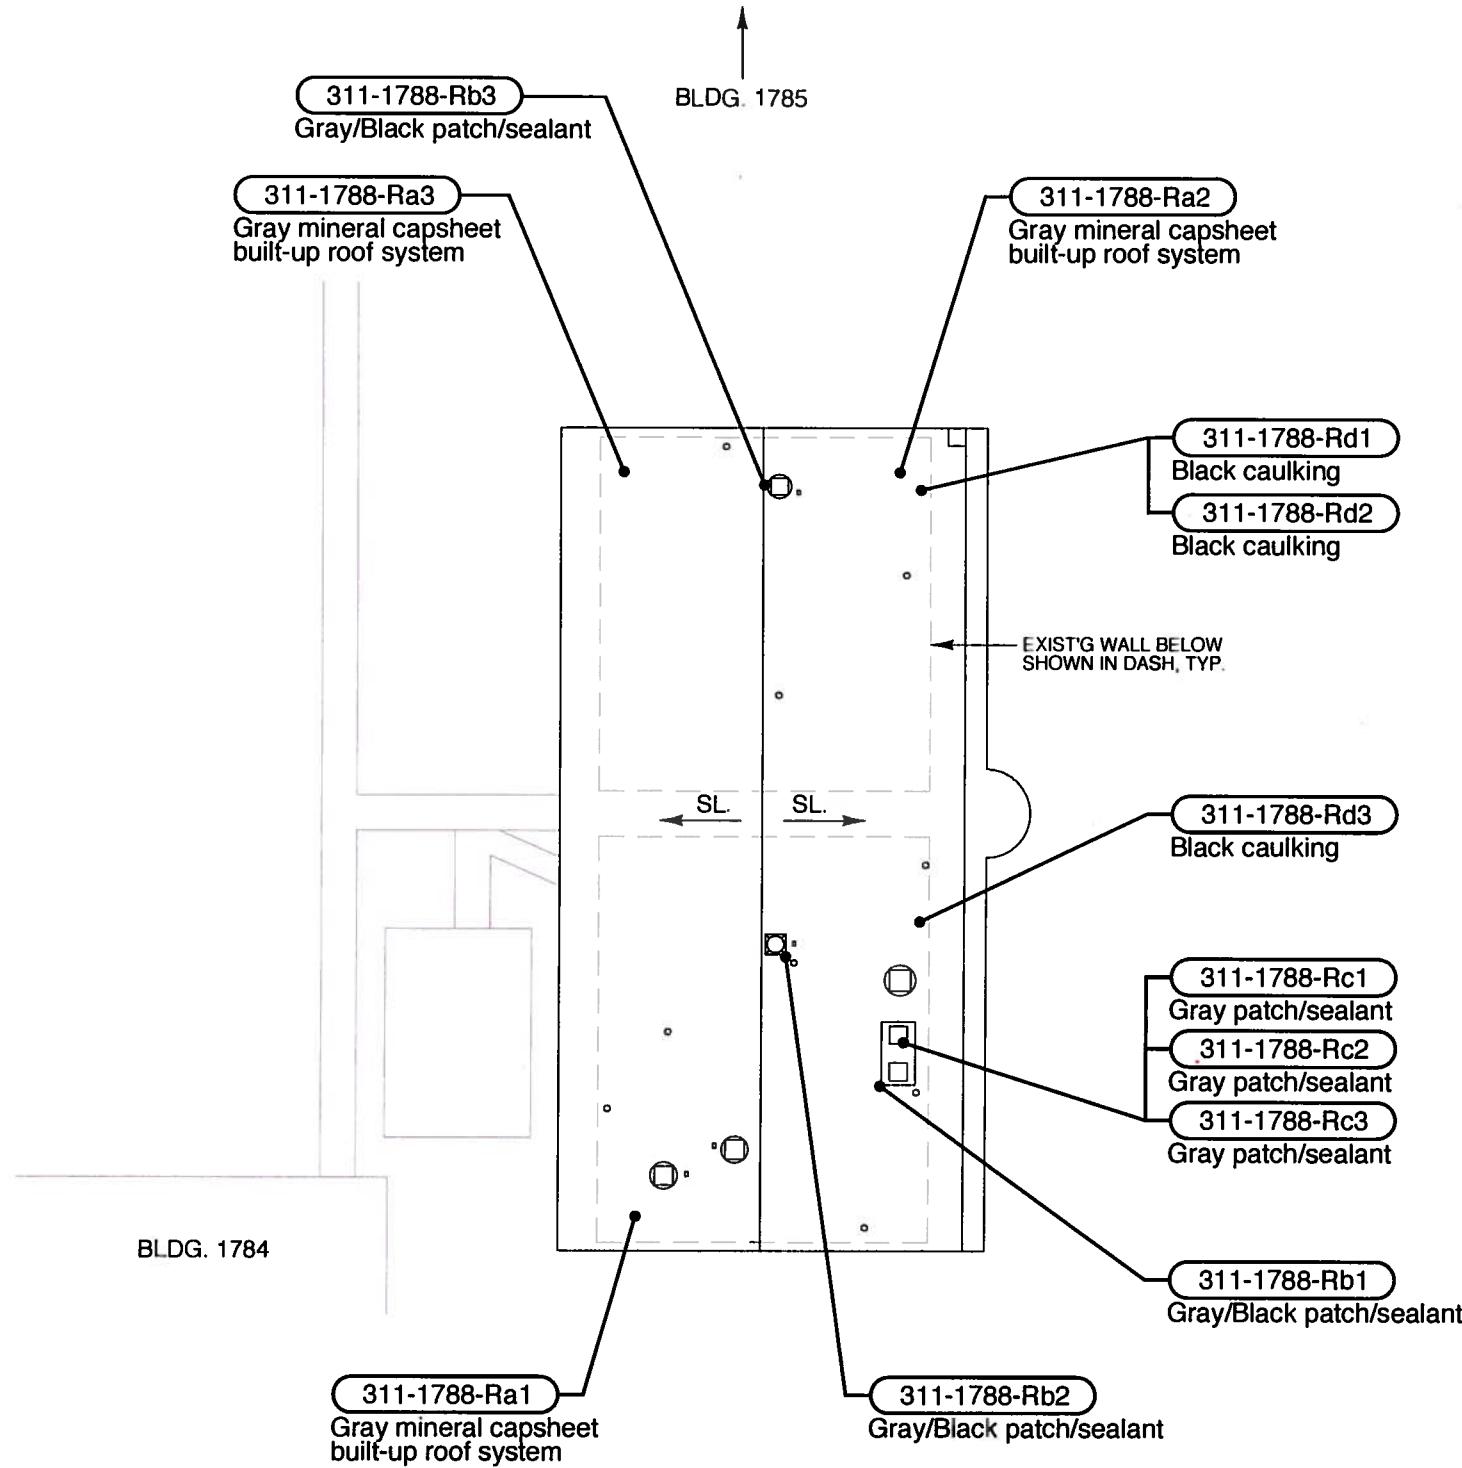
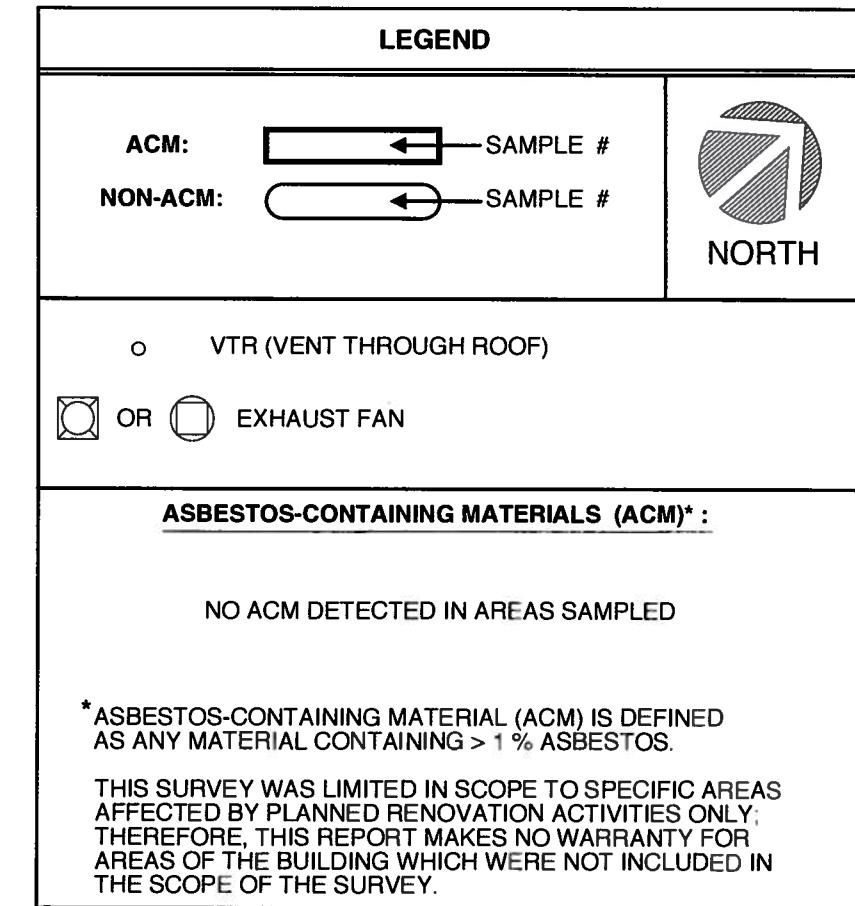
BLDG #	NAME OF BUILDING	ADDRESS	SKETCH #
1788	BUILDING 1788	91 ENTERPRISE STREET KAPOLEI, HI 96707	311-1788-R 1 OF 1

**HAWAII AIR NATIONAL GUARD (DEPARTMENT OF DEFENSE)
BUILDING "1788" - ROOF PLAN**
NOT TO SCALE
