Letter Report

Limited Asbestos Survey

Birkhimer EOC
Oahu, Hawaii

Subject: **Limited Asbestos Survey**
Birkhimer Emergency Operations Center (EOC), Oahu, Hawaii
Consultant Services Contract No. CA-1606-D, Change Order Nos. 5 & 13
E2 Project 190025

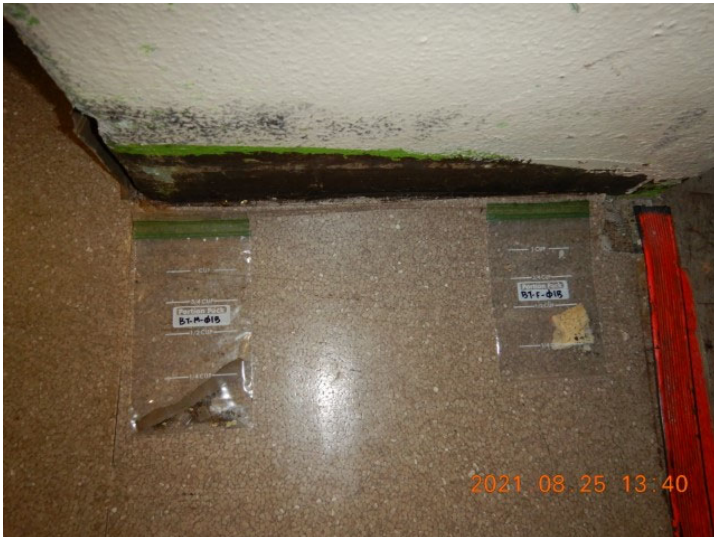
Photo 17 - BT-F-01B (Close-up)

Sample ID	Lab Number	Asbestos Type	Percent in Layer	Asbestos Type	Percent in Layer	Asbestos Type	Percent in Layer
BT-F-01A	51472026						
Layer: Grey Sheet Flooring			ND				
Layer: Fibrous Backing			ND				
Layer: Yellow Mastic			ND				
Layer: Grey Non-Fibrous Material			ND				
Layer: Black Mastic		Chrysotile	3 %				
Total Composite Values of Fibrous Components:		Asbestos (Trace)					
Cellulose (20 %)		Fibrous Glass (3 %)		Synthetic (10 %)			
BT-F-01B	51472027						
Layer: Grey Sheet Flooring			ND				
Layer: Fibrous Backing			ND				
Layer: Yellow Mastic			ND				
Layer: Grey Non-Fibrous Material			ND				
Layer: Black Mastic		Chrysotile	3 %				
Total Composite Values of Fibrous Components:		Asbestos (Trace)					
Cellulose (20 %)		Fibrous Glass (3 %)		Synthetic (10 %)			
BT-F-01C	51472028						
Layer: Grey Sheet Flooring			ND				
Layer: Fibrous Backing			ND				
Layer: Yellow Mastic			ND				
Layer: Black Mastic		Chrysotile	2 %

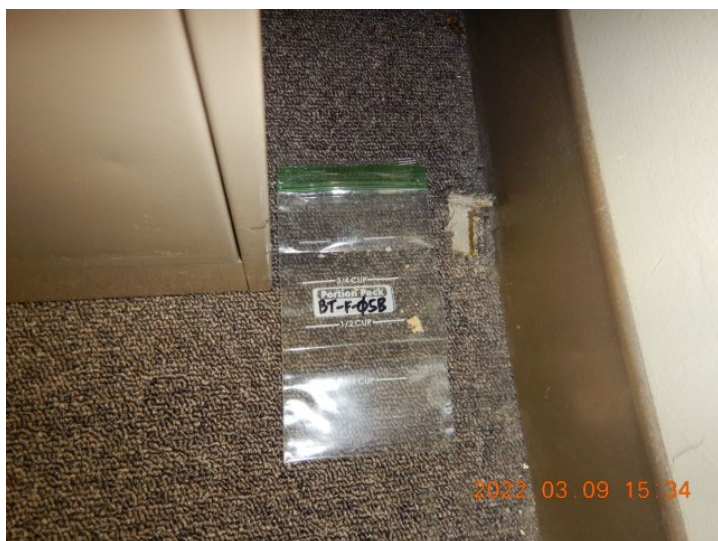
Photo 41 - BT-F-05B (Close-up)

Client Name: Element Environmental, LLC				Report Number: B330274			
				Date Printed: 03/11/22			
Sample ID	Lab Number	Asbestos Type	Percent in Layer	Asbestos Type	Percent in Layer	Asbestos Type	Percent in Layer
BT-F-05B	51526765						
Layer: Grey Carpet Debris			ND				
Layer: Black/Tan Mastics		Chrysotile	2 %				
Layer: Off-White Non-Fibrous Material			ND				
Total Composite Values of Non-Asbestos Fibrous Components:							
Cellulose (Trace) Synthetic (5 %)							
BT-F-05C	51526766						
Layer: Grey Carpet Debris			ND				
Layer: Black/Tan Mastics		Chrysotile	2 %				
Layer: Off-White Non-Fibrous Material			ND				
Layer: Grey Non-Fibrous Material			ND				
Layer: Brown Mastic			ND				
Total Composite Values of Non-Asbestos Fibrous Components:							
Cellulose (Trace) Synthetic (5 %)							
BT-M-03A	51526767						
Layer: Brown Non-Fibrous Material			ND				
Layer: Brown Mastic			ND				
Total Composite Values of Non-Asbestos Fibrous Components:
