## **SECTION 01715 – EXISTING CONDITIONS – LEAD / HAZARDOUS MATERIAL SURVEY**

4. **Project Name:** Limited Hazardous Materials Survey (Survey) for Building 19 Site Improvements, located at Hawaii Army National Guard, Kalaeloa

Limited Hazardous Materials Survey  
 Building 19, Site Improvements  
 Hawaii Army National Guard, Oahu, Hawaii  
 Job No. CA-1514-D

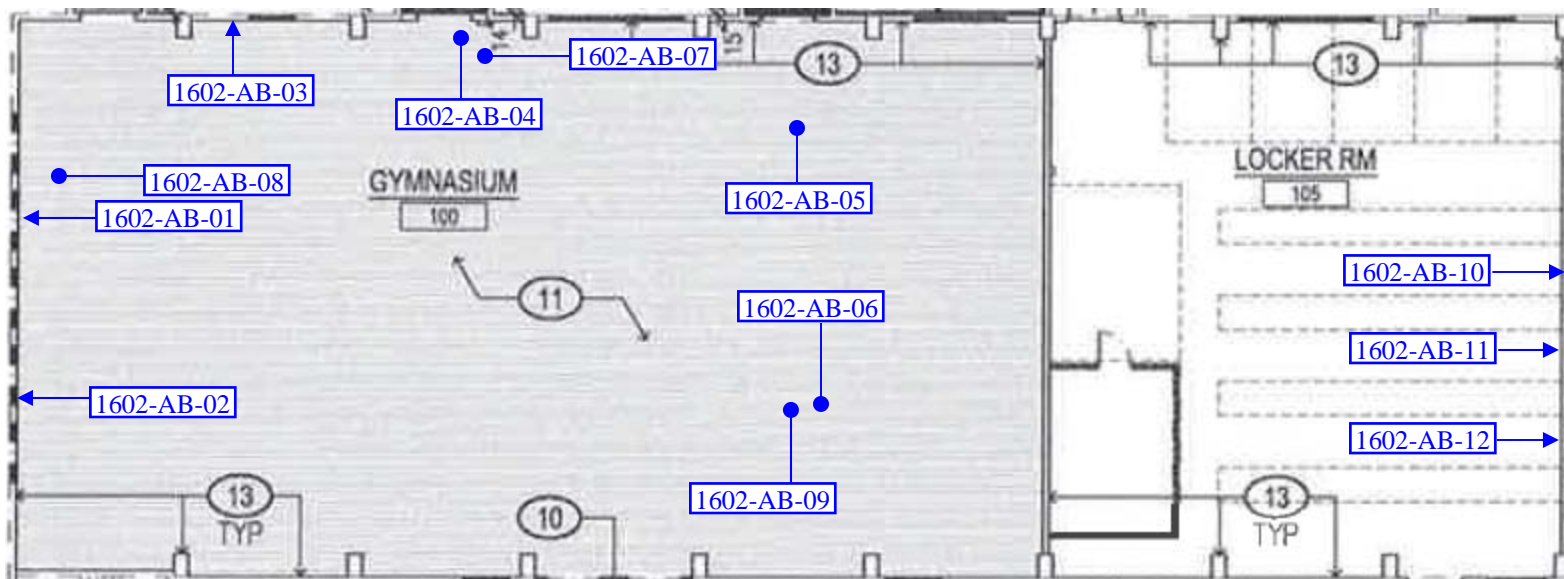
### **SAMPLE LOCATION MAP**

1602-AB-XX	Asbestos Containing
1602-AB-XX	Non-Asbestos Containing
1602-AB-XX	Not Analyzed

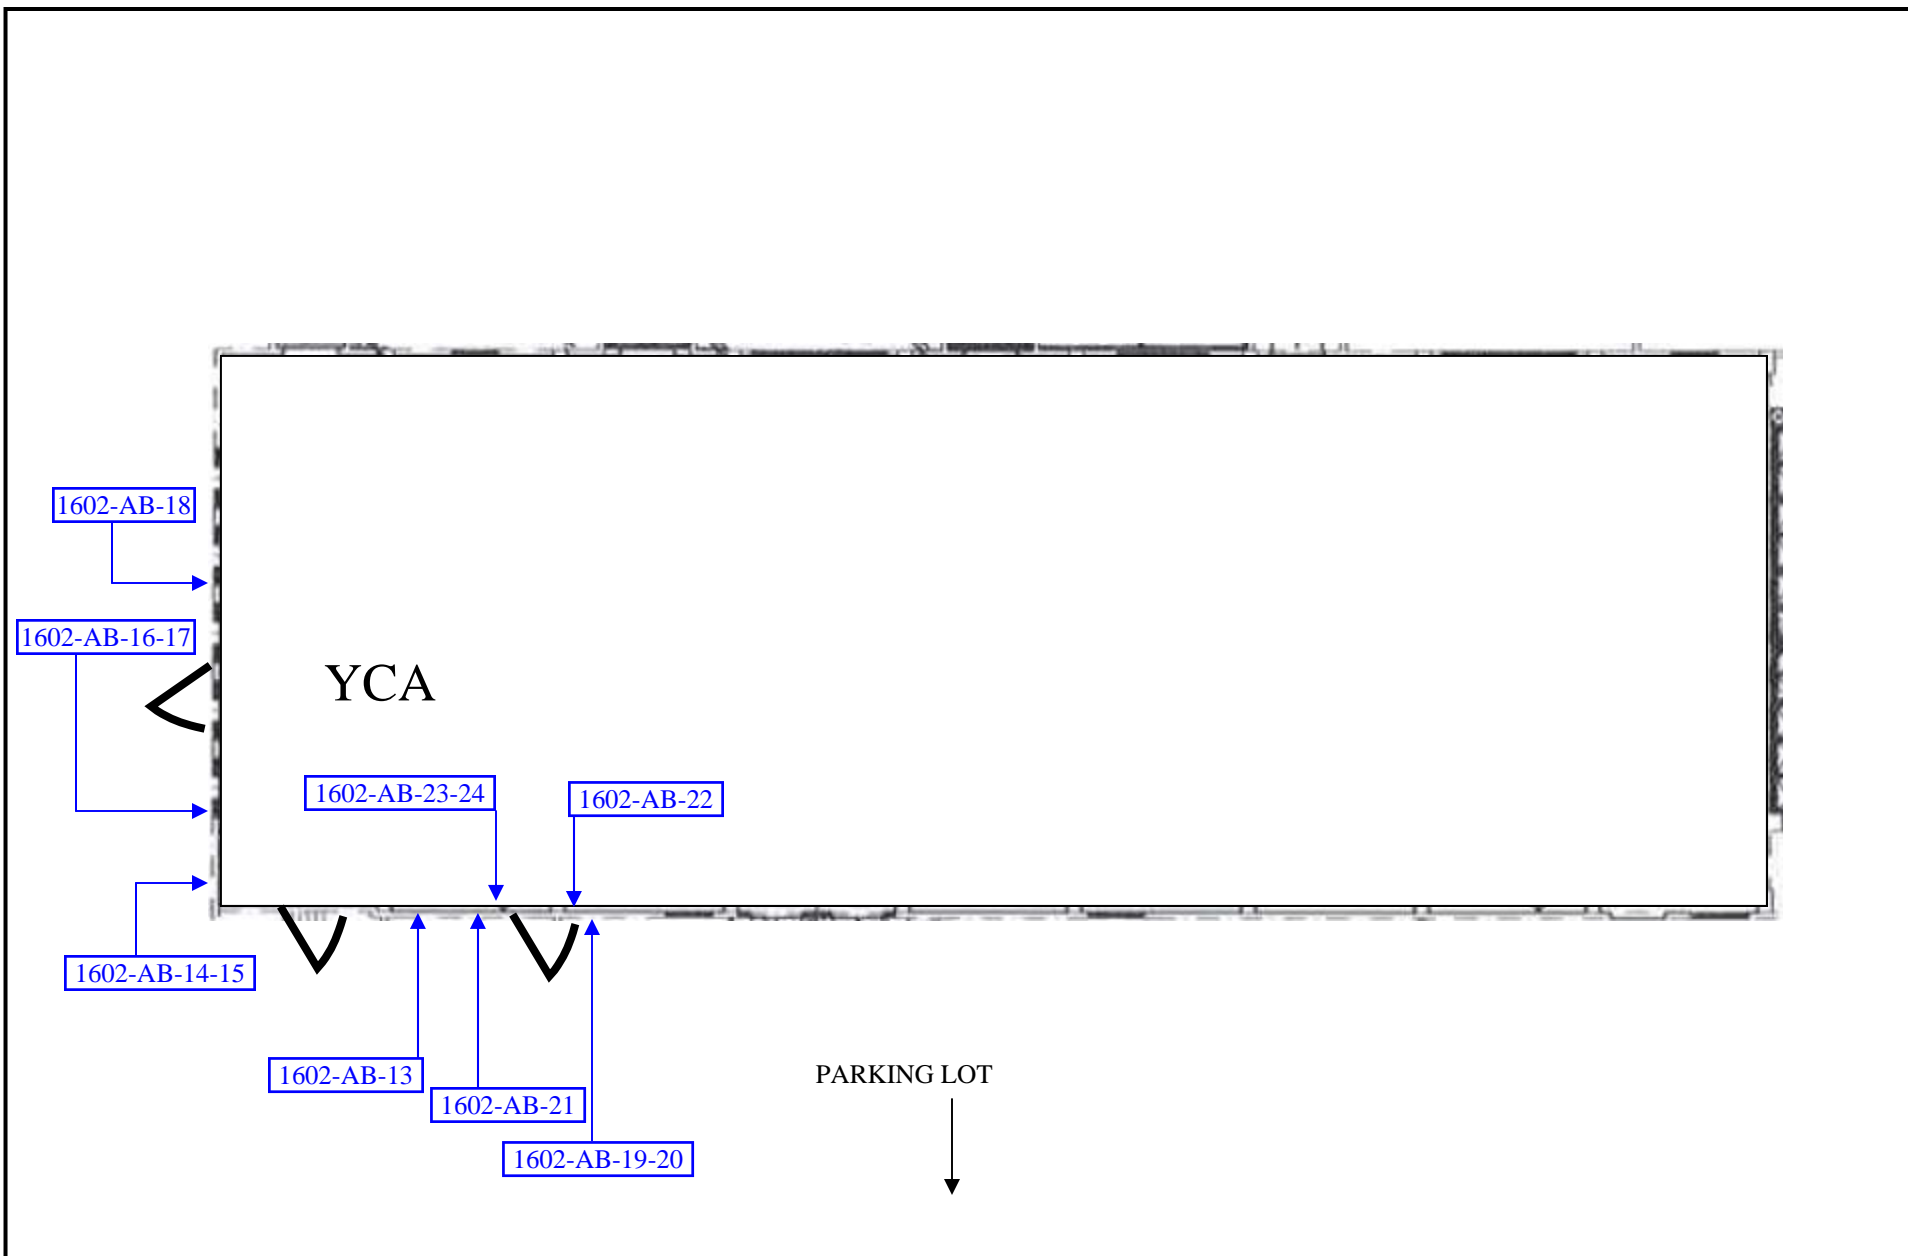
**ASBESTOS SAMPLE LOCATION MAP**

<p><b>Legend</b></p> <p>1602-AB-XX Asbestos Containing</p> <p>1602-AB-XX Non-Asbestos Containing</p> <p>1602-AB-XX Not Analyzed</p>	 	<p>ETC Project No. 16-4002</p> <p>March 2017</p>	<p><b>ASBESTOS SAMPLE LOCATION MAP</b></p> <p>Limited Hazardous Materials Survey</p> <p>Building 19, Site Improvements</p> <p>Hawaii Army National Guard, Oahu, Hawaii</p> <p>Job No. CA-1514-D</p>
---	--	--	---
